Effects of ProcellaCOR in Lake George

Initial results from the monitoring of Blairs Bay and Jelliffe-Knight Bay by The Jefferson Project and the Lake George Association (LGA)

September 3, 2024

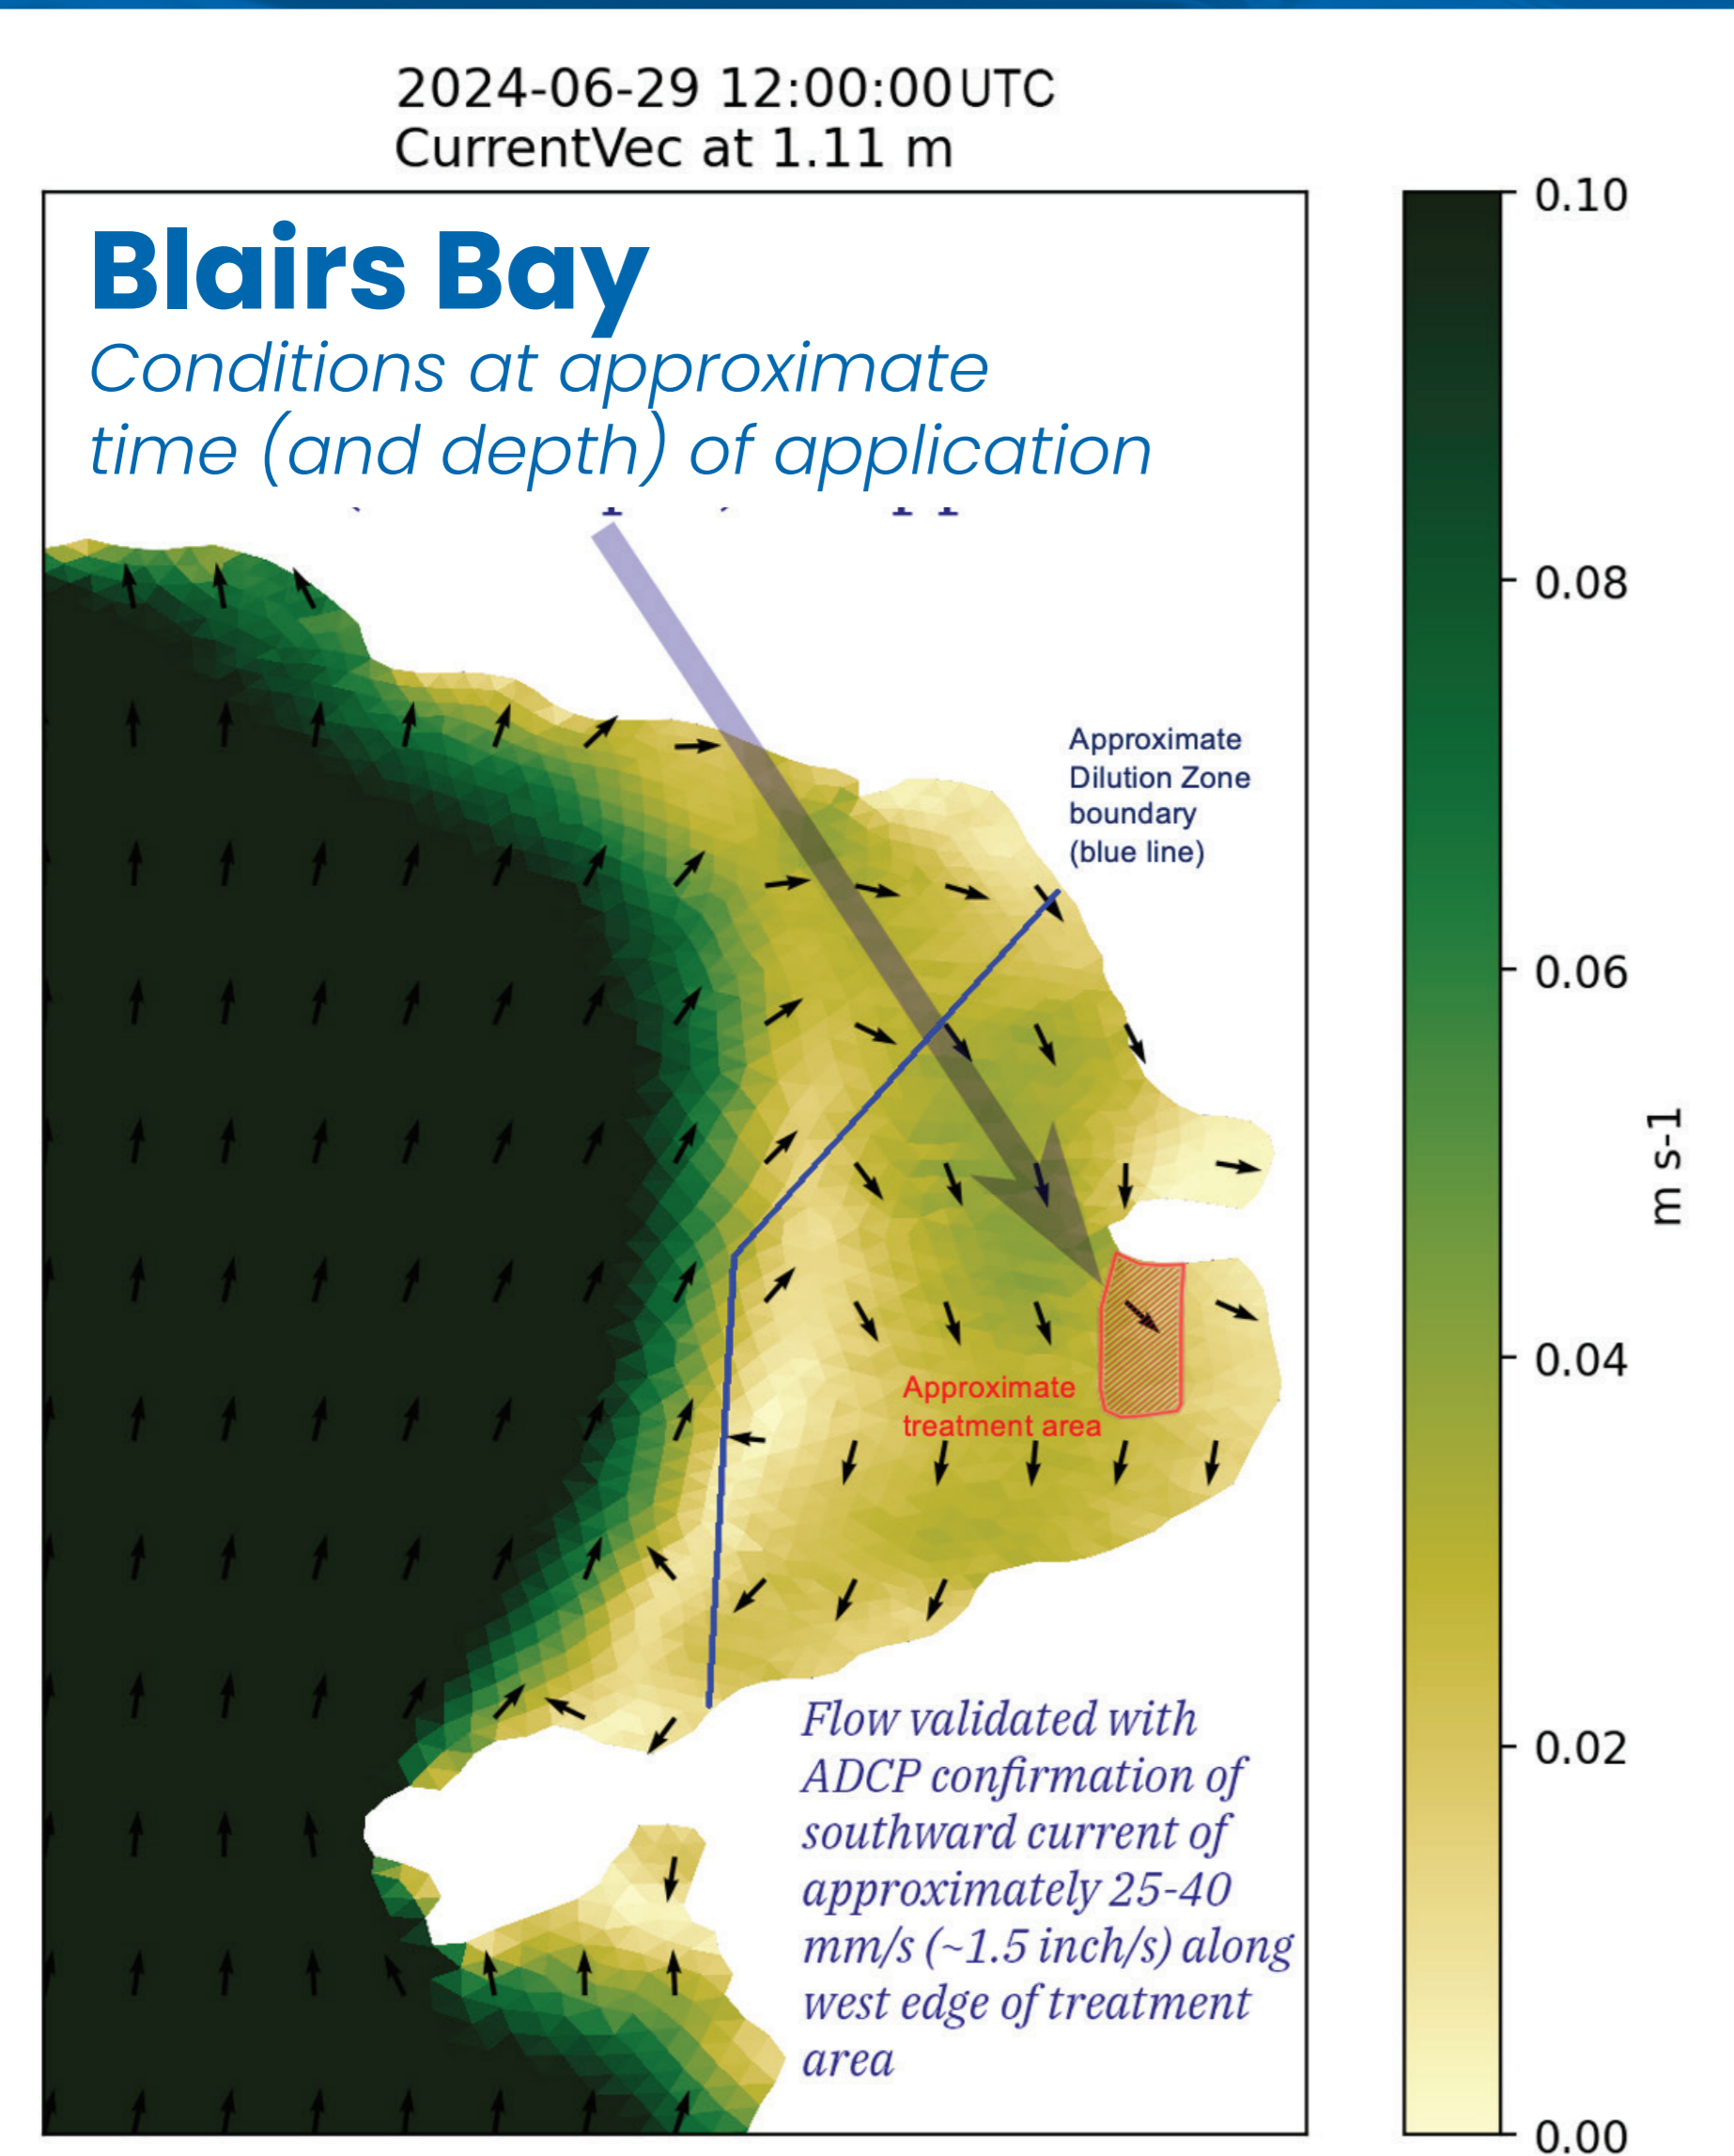
Water Circulation in the Bays on June 29, 2024

These are circulation models of the water movement, both direction and speed, in the two Lake George bays. They were made by The Jefferson Project the morning of June 29 at the time of ProcellaCOR treatment in the areas shown in red. The flows were validated by acoustic doppler current profilers in the Lake.

In Blairs Bay on the left, you can see a north-to-south clockwise water movement, which affected the efficacy and uniformity of the herbicide, and also transported the chemical outside of the treatment zone.

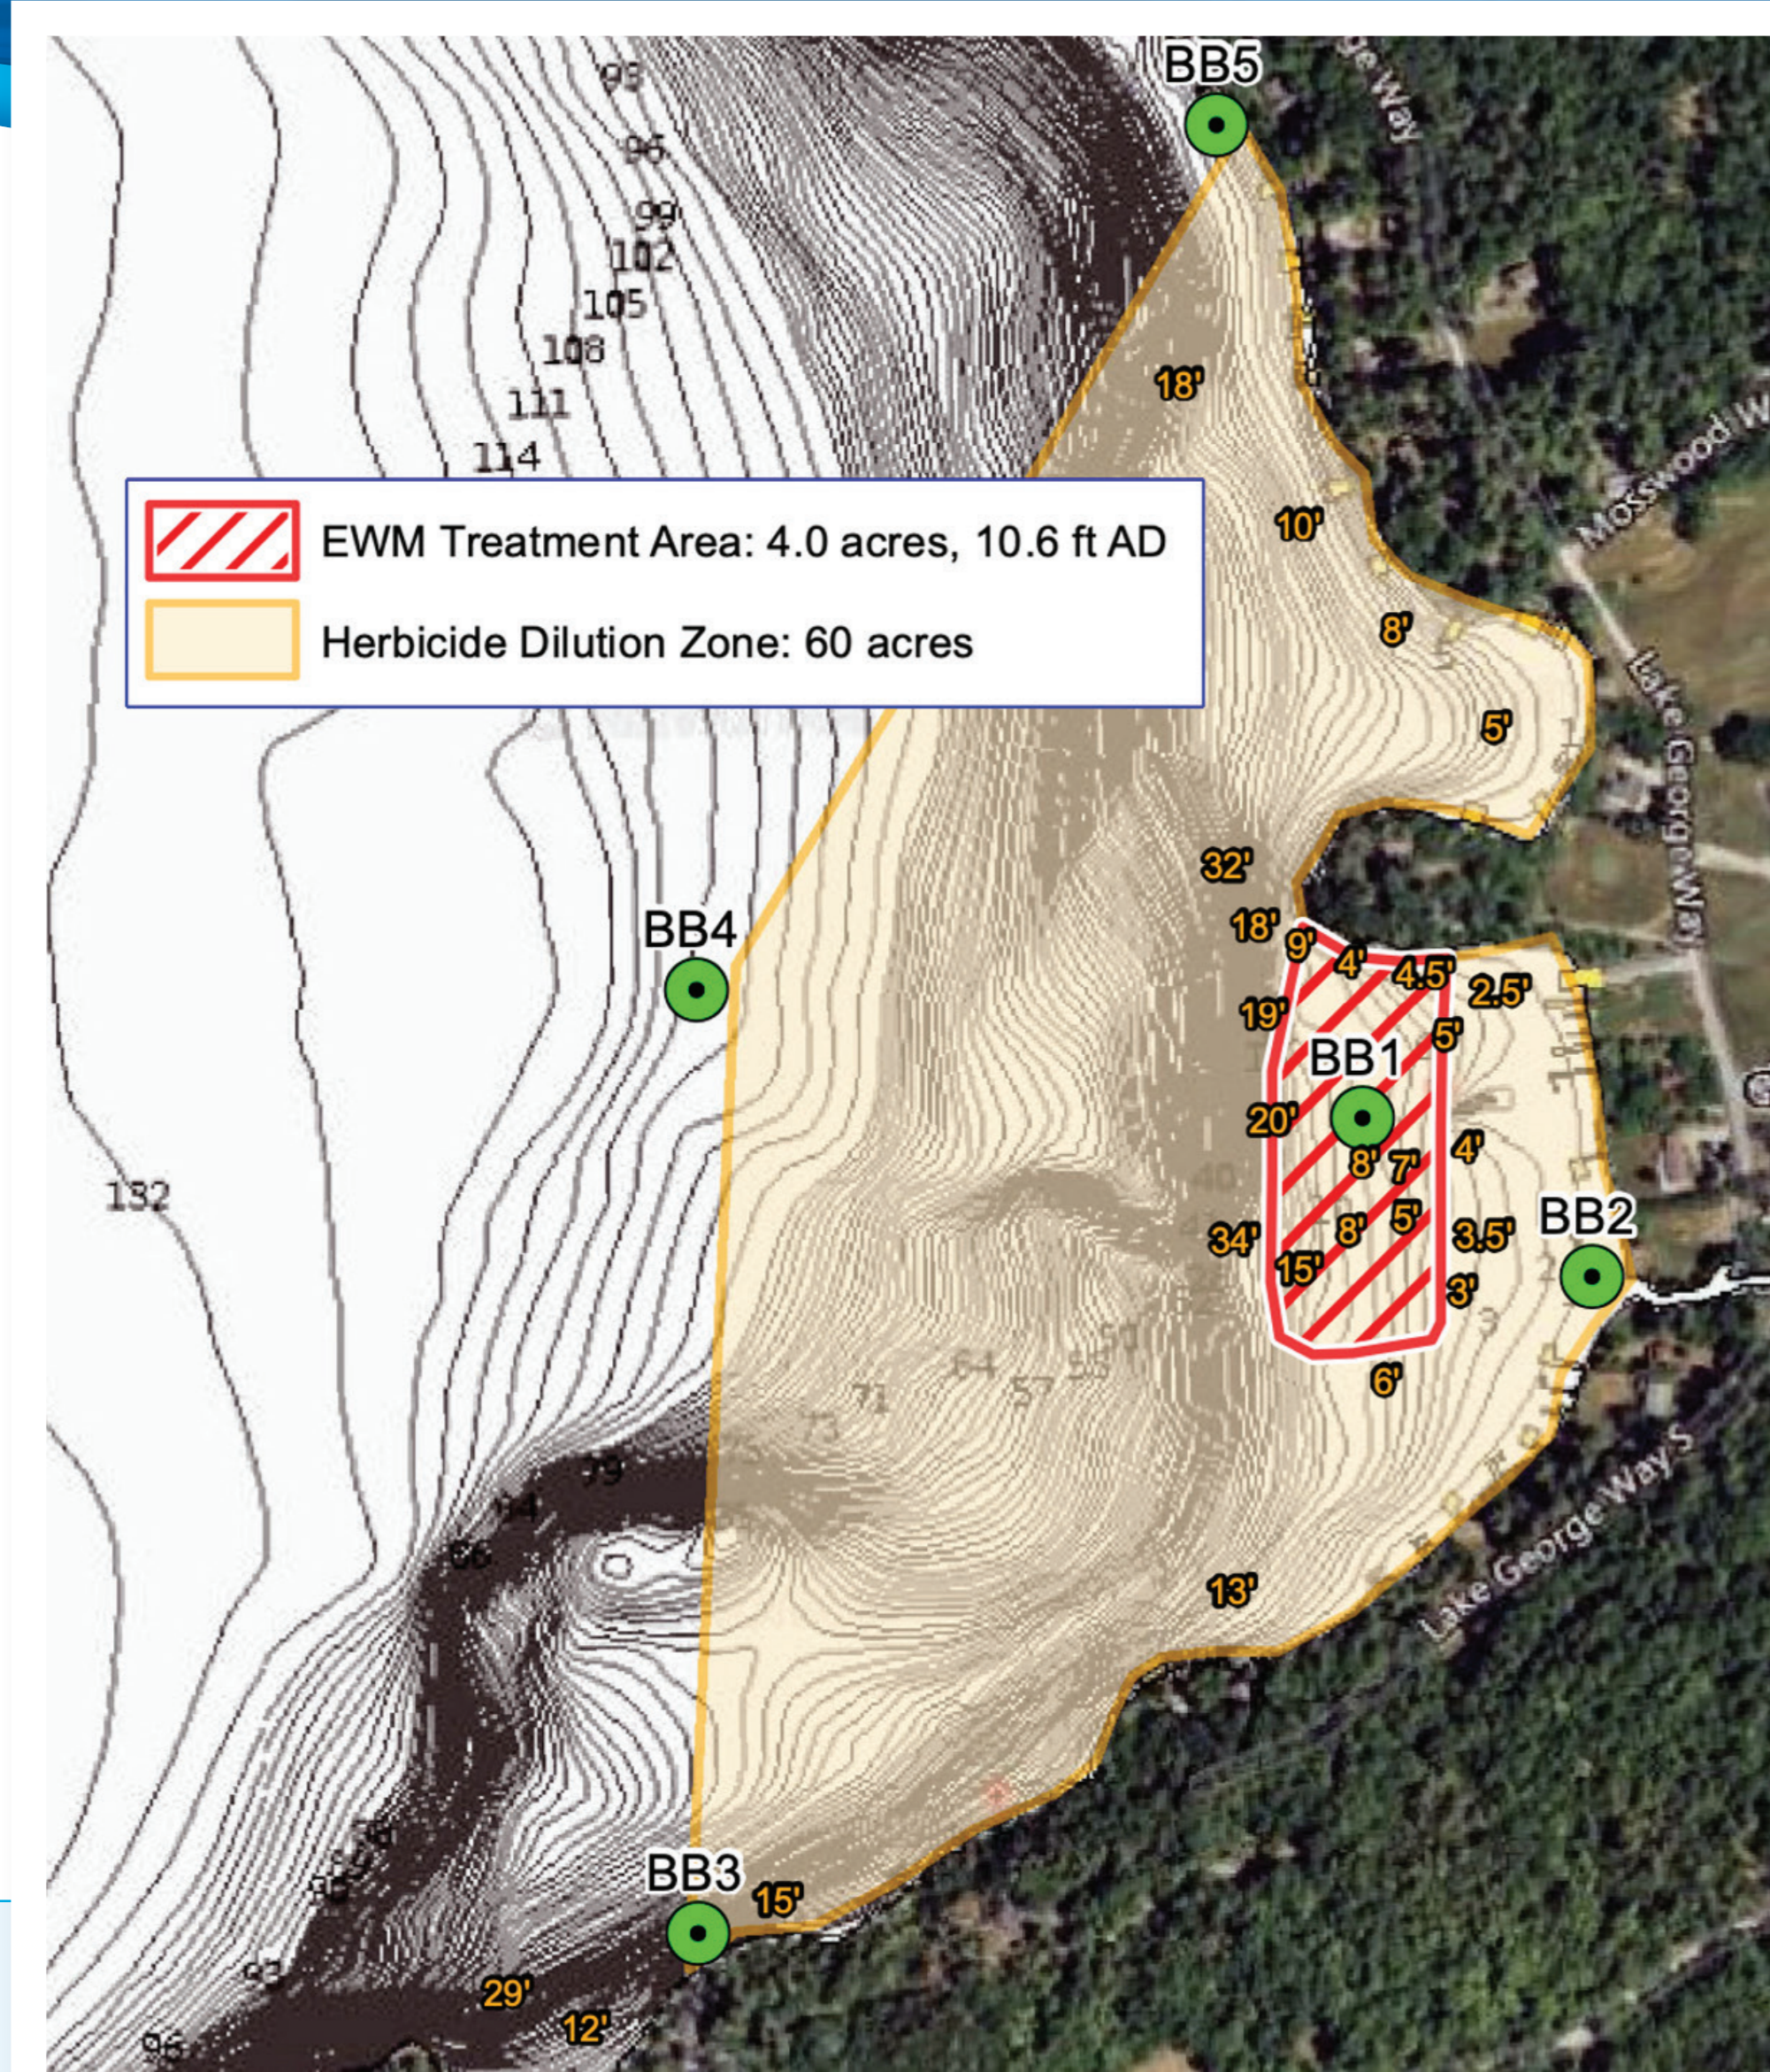
Blairs Bay Treatment and Dilution Zones

ProcellaCOR was applied to Blairs Bay in the red area shown here, the treatment zone. The tan area surrounding it indicates the dilution zone, which is the area estimated to be exposed to ProcellaCOR, as defined by models from New York State that are based on uniform distribution of herbicide application.

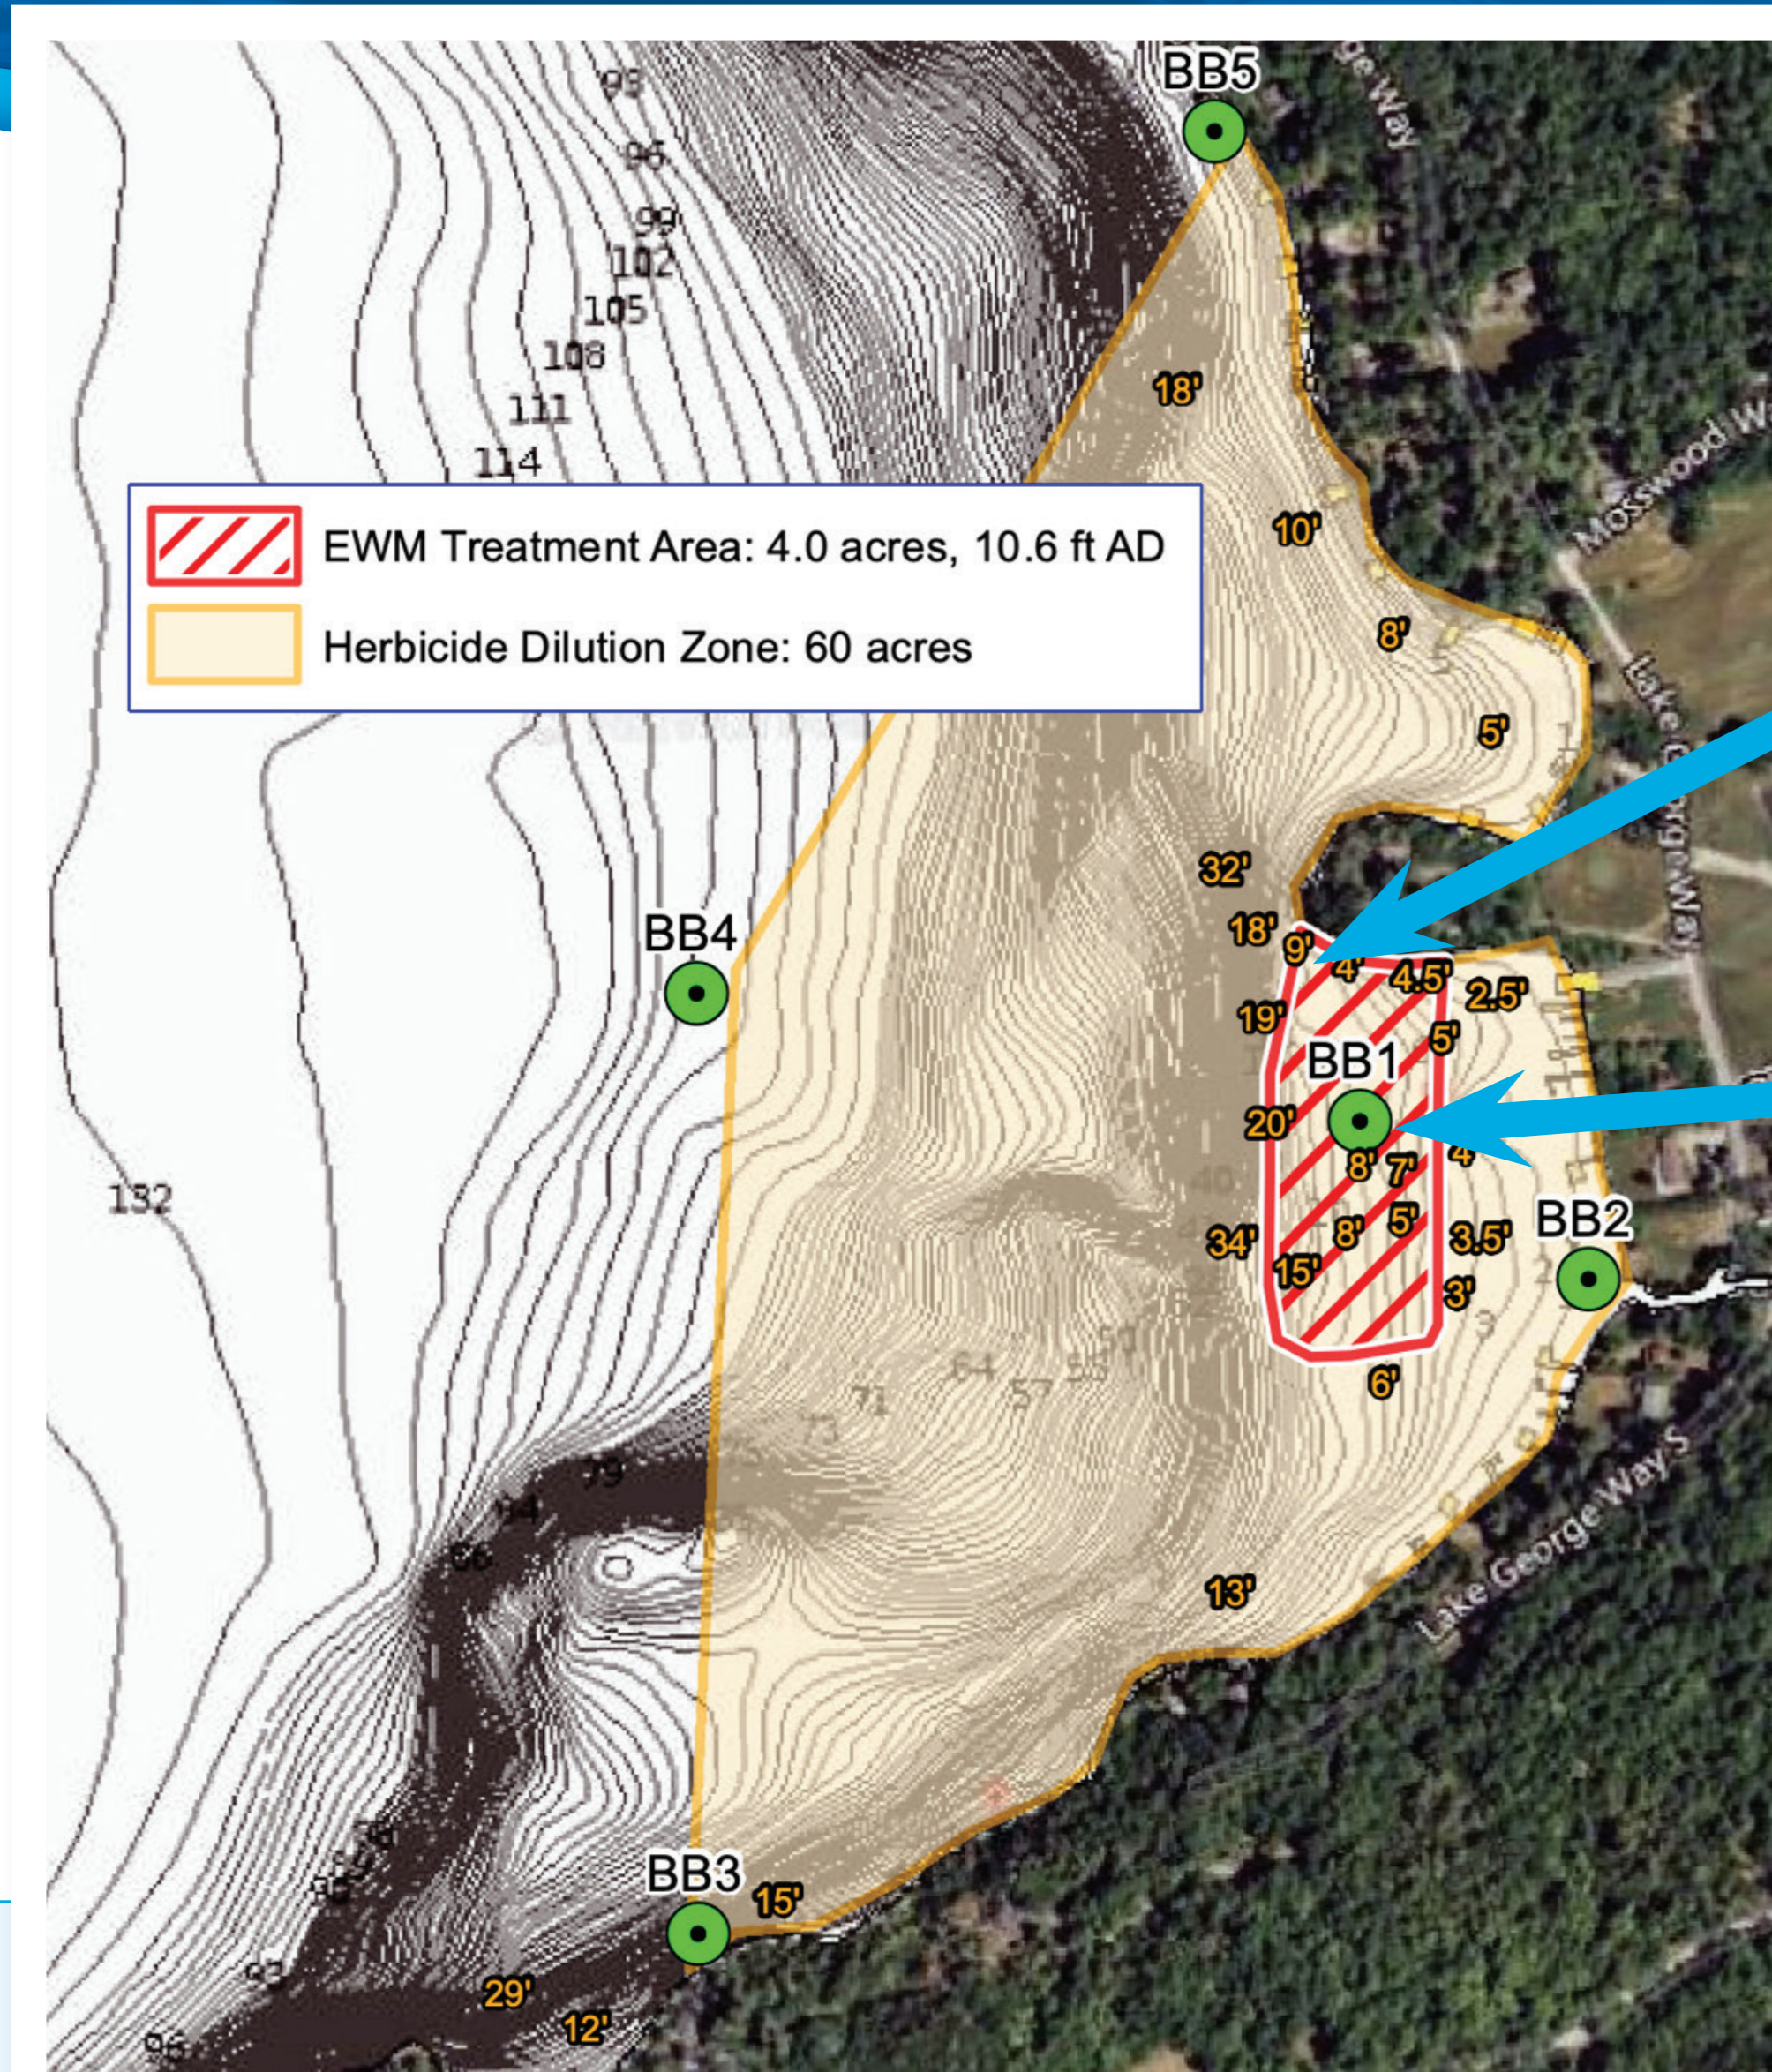
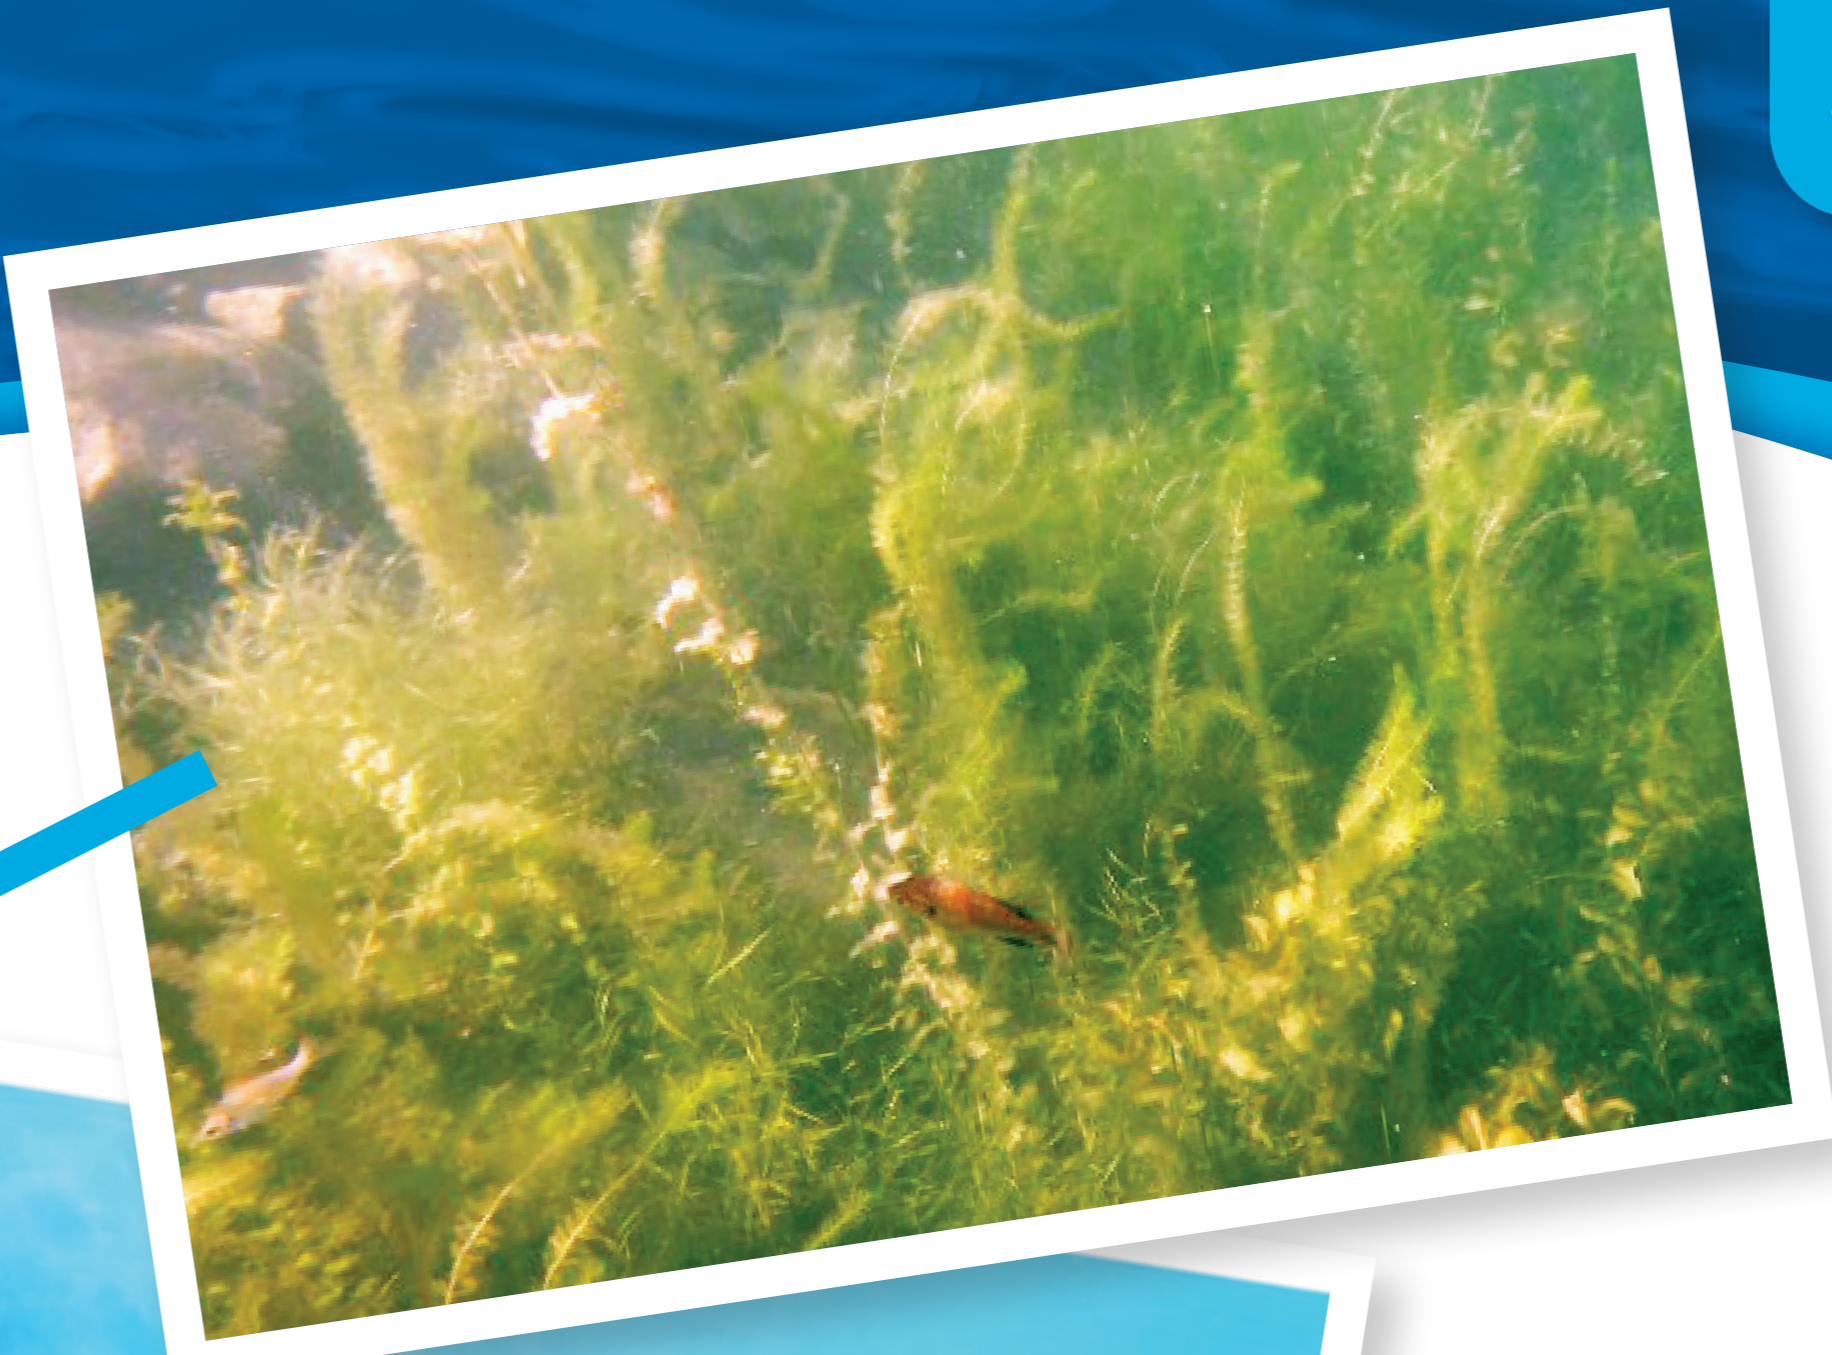
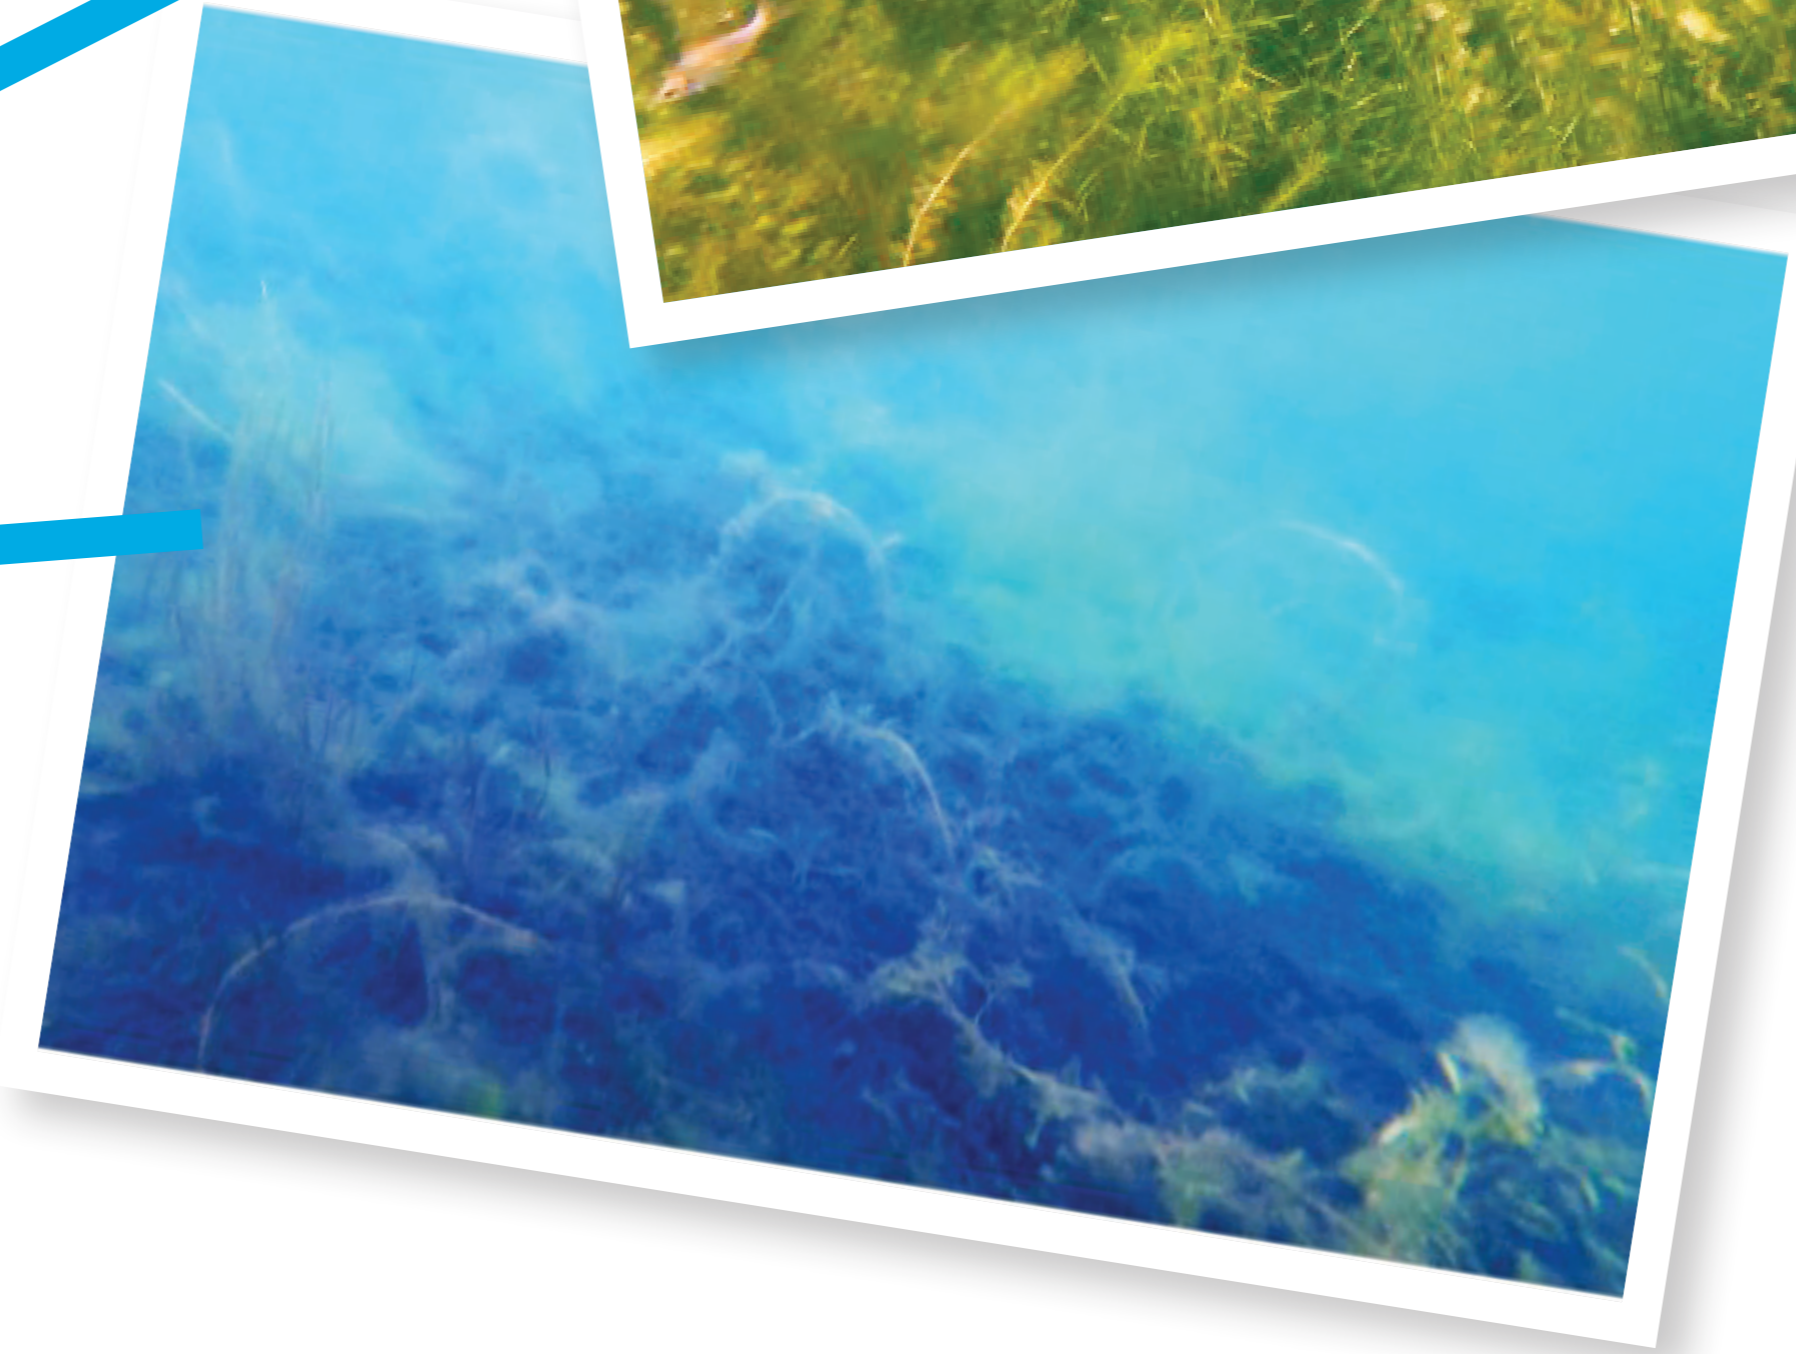
Uneven Impacts on EWM

In early August, The Jefferson Project's underwater remotely operated vehicle took photos of Blairs Bay. The EWM was dead in the middle of the treatment zone, however, in the northern section of the zone, EWM does not appear to be impacted, due to north-to-south direction of the Lake water at the time of application on June 29.
