Effects of ProcellaCOR in Lake George

Initial results from the monitoring of Blairs Bay and Jelliffe-Knight Bay by The Jefferson Project and the Lake George Association (LGA)

September 3, 2024

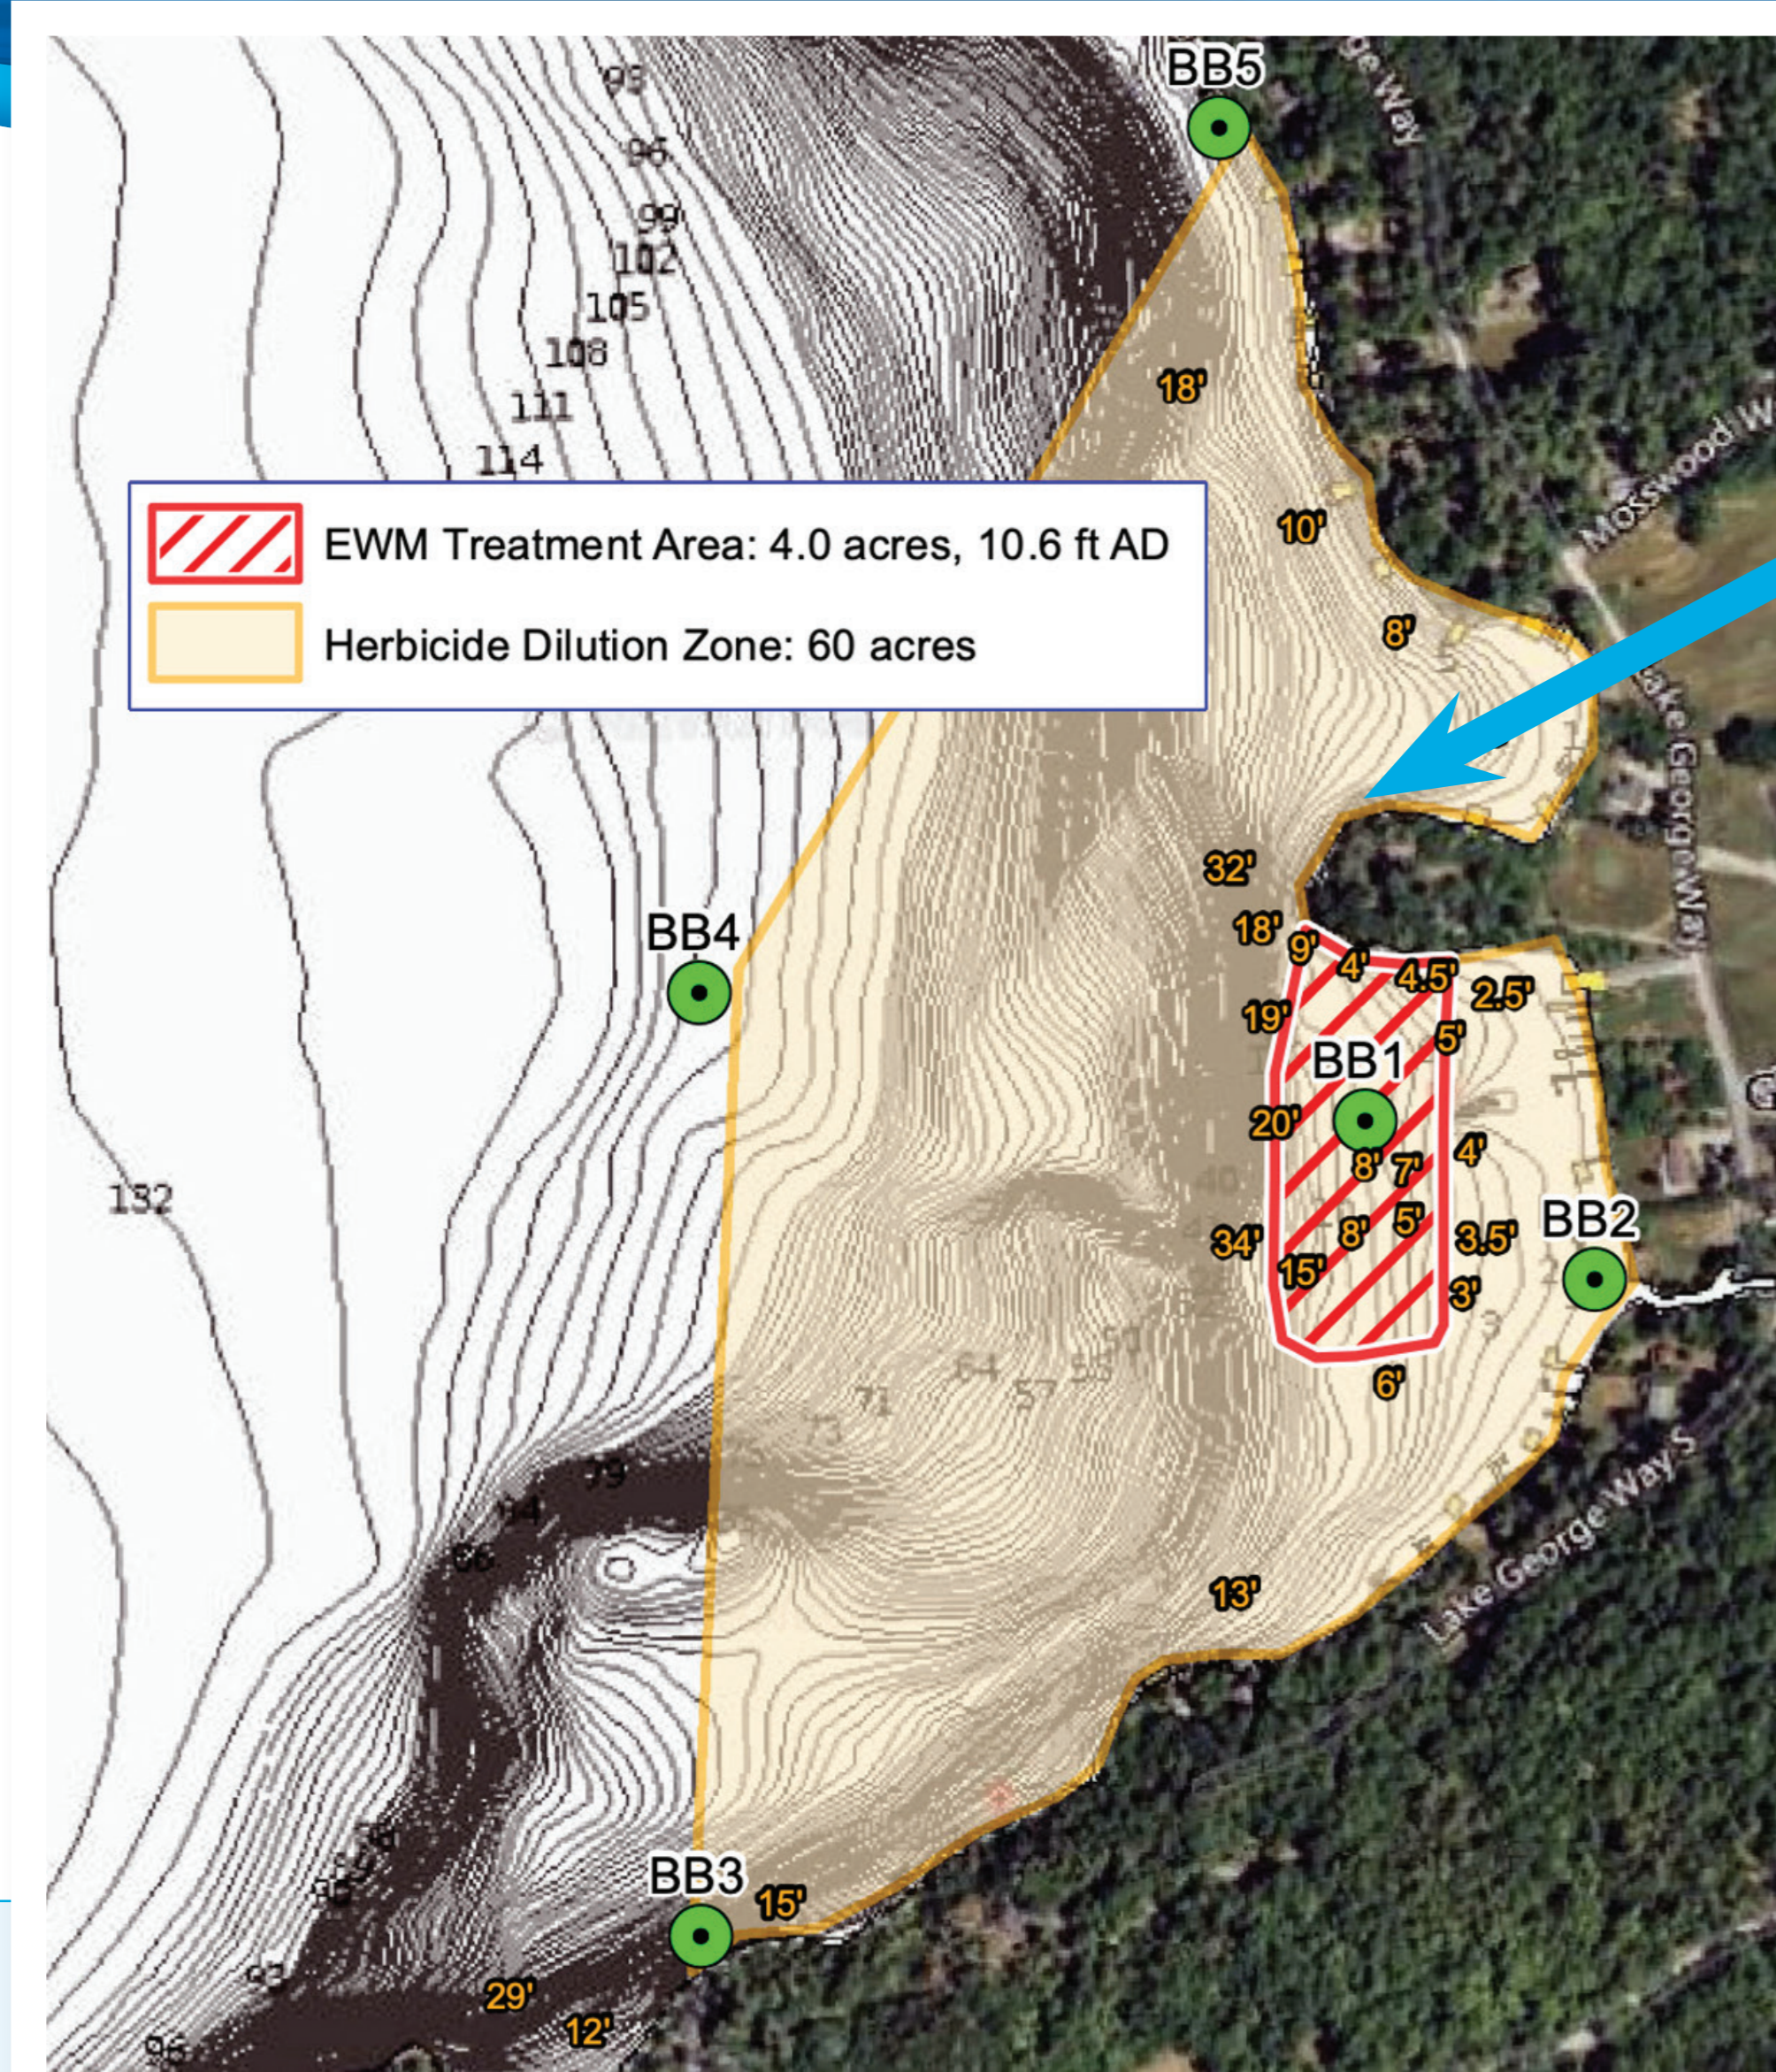
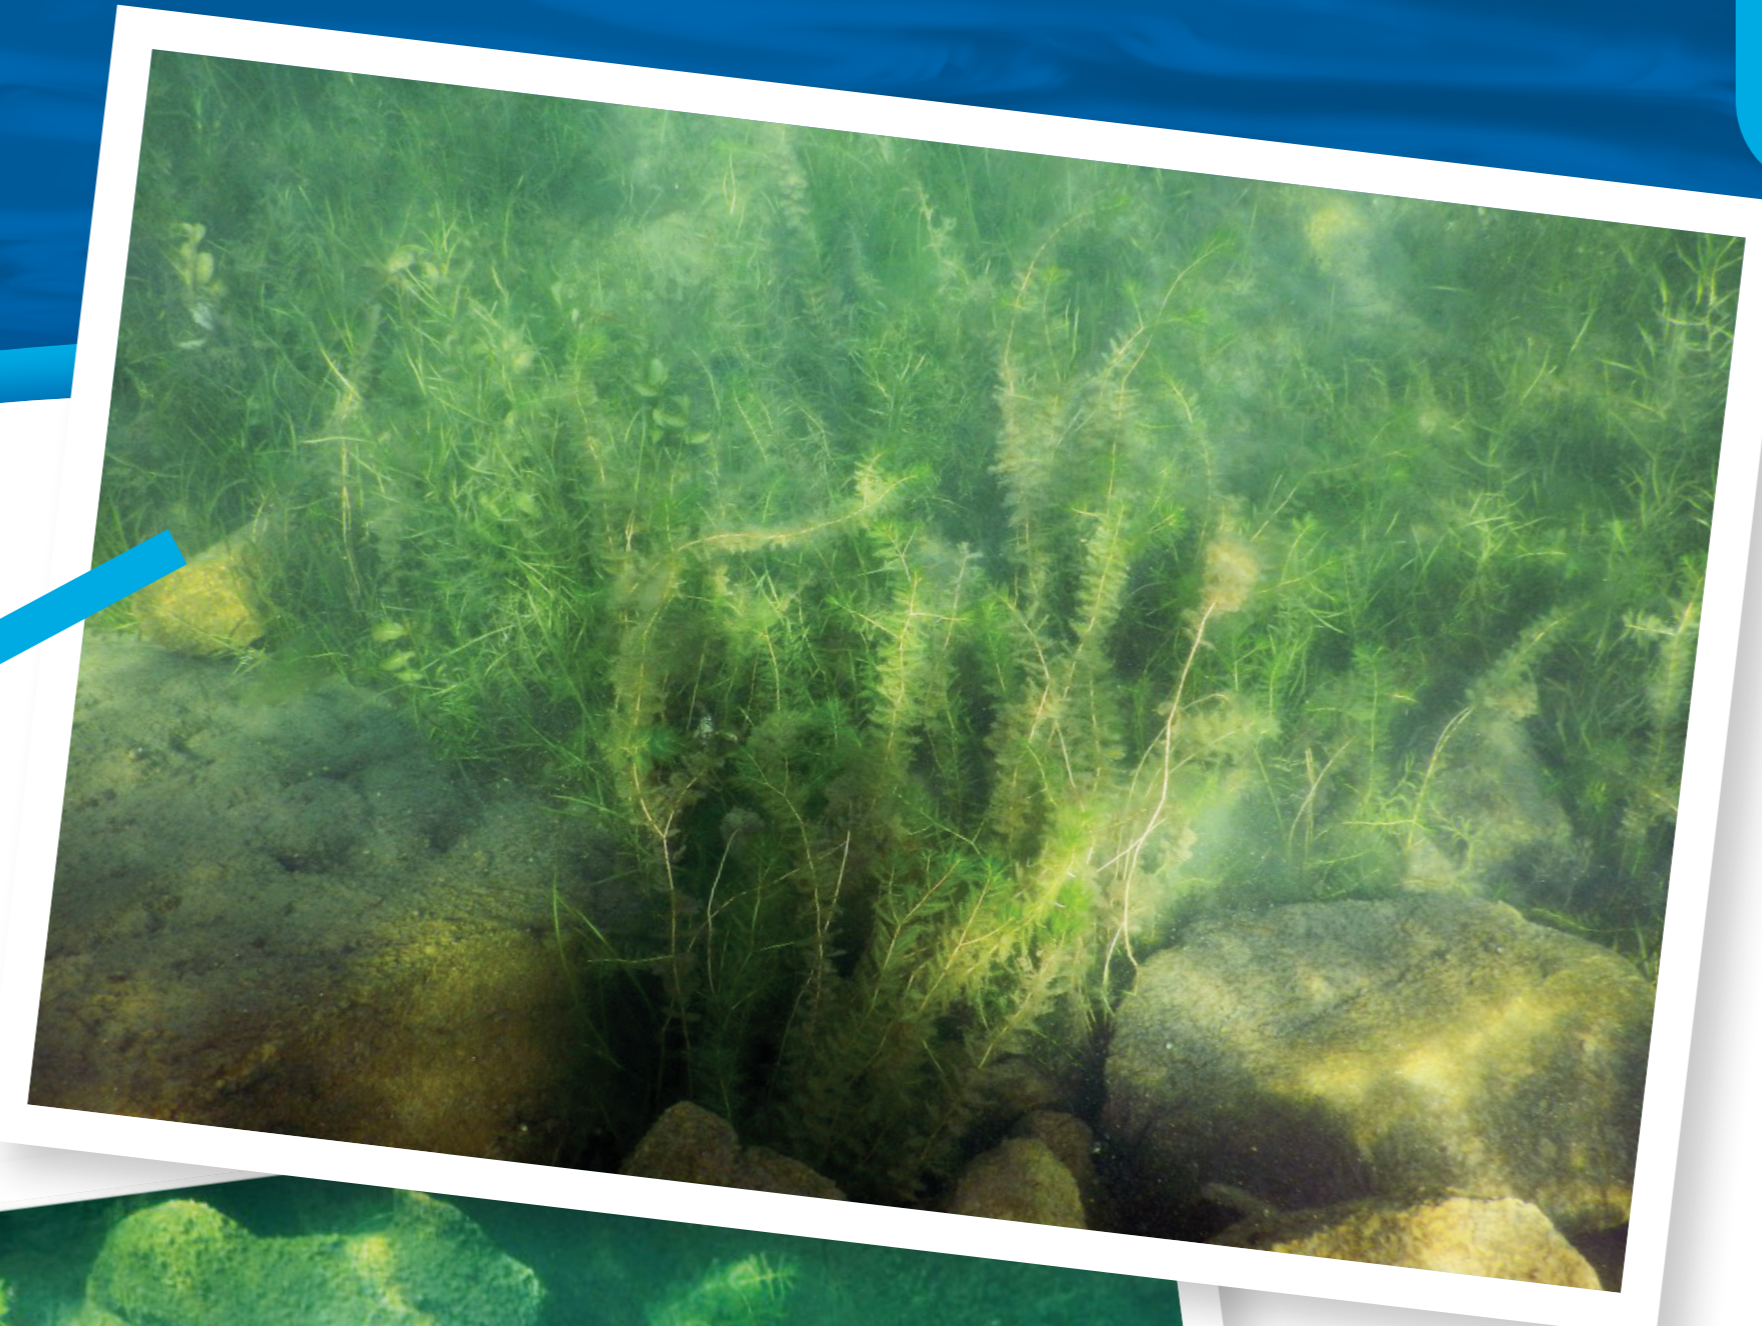
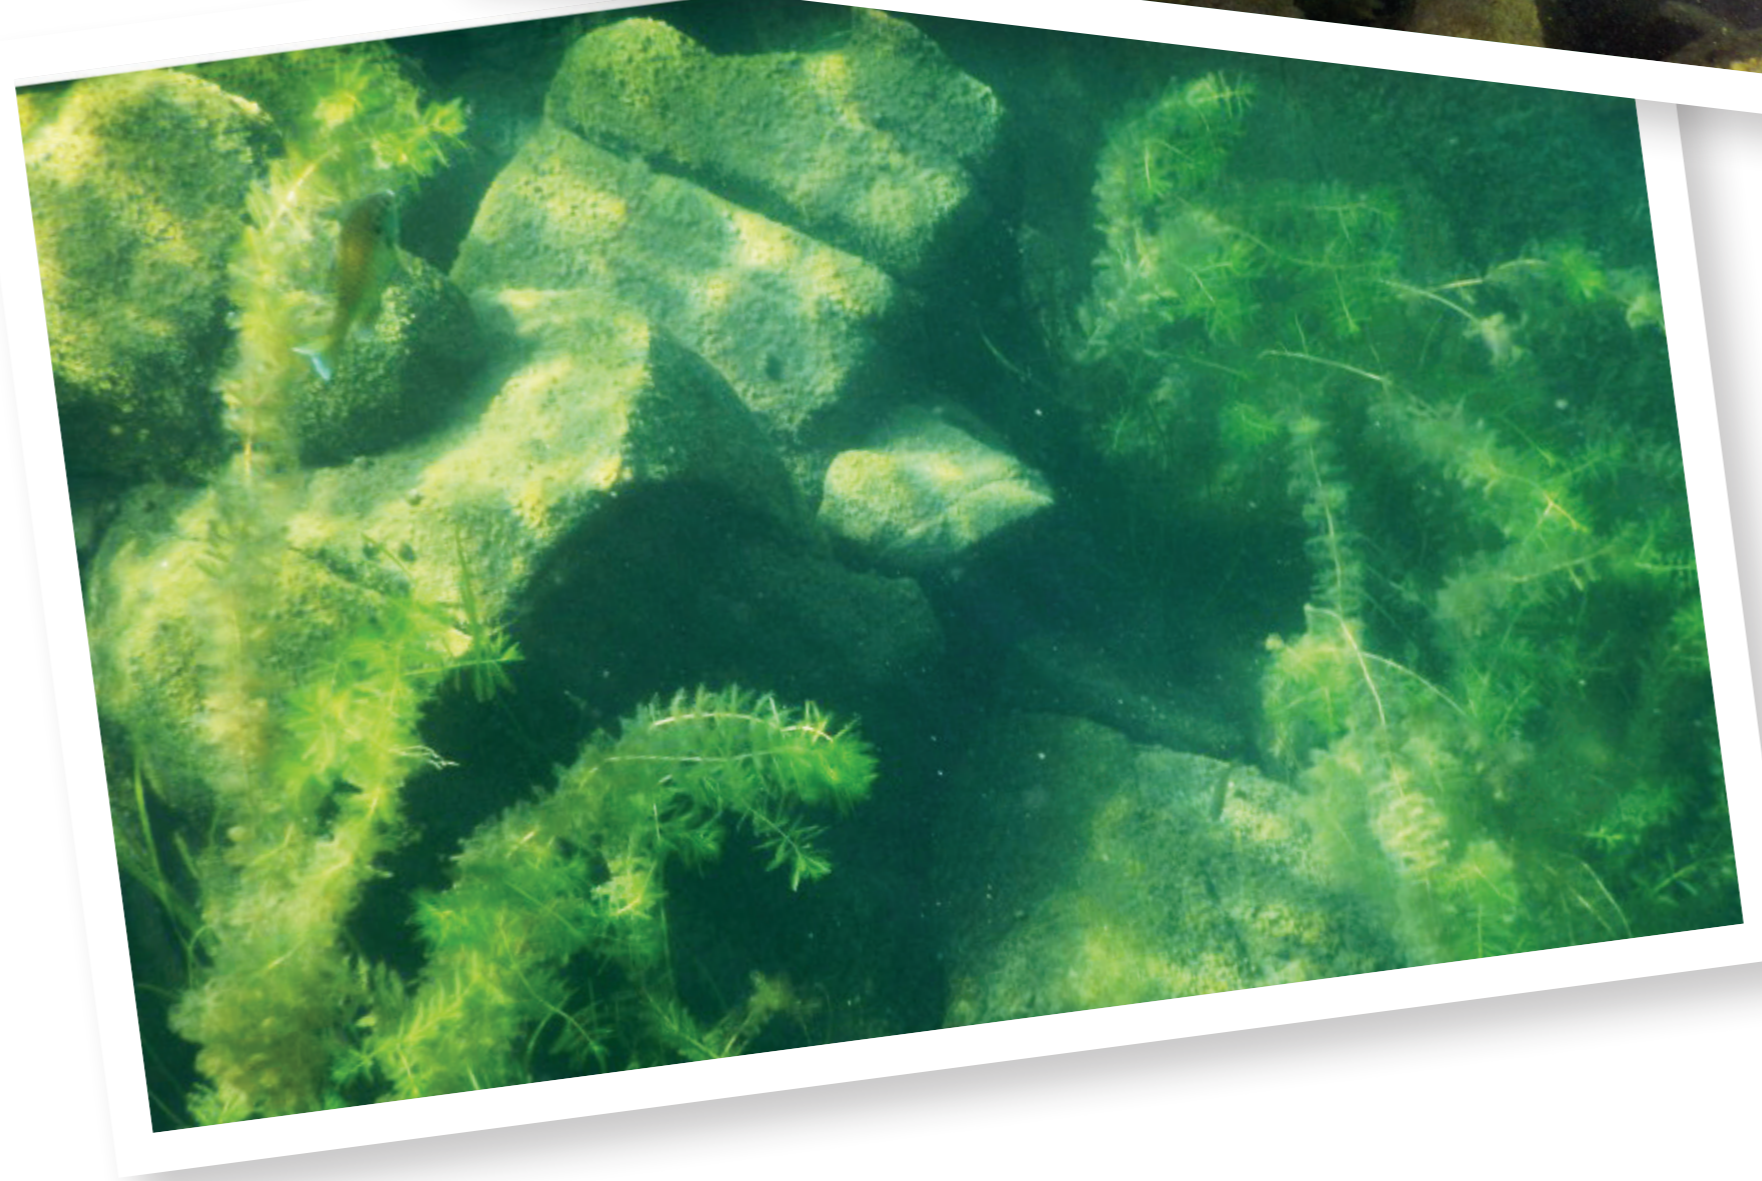
Uneven Impacts on EWM

Just north of the treatment zone in Blairs Bay, photos from August 14 show largely unaffected EWM in the dilution zone along Davis Point.

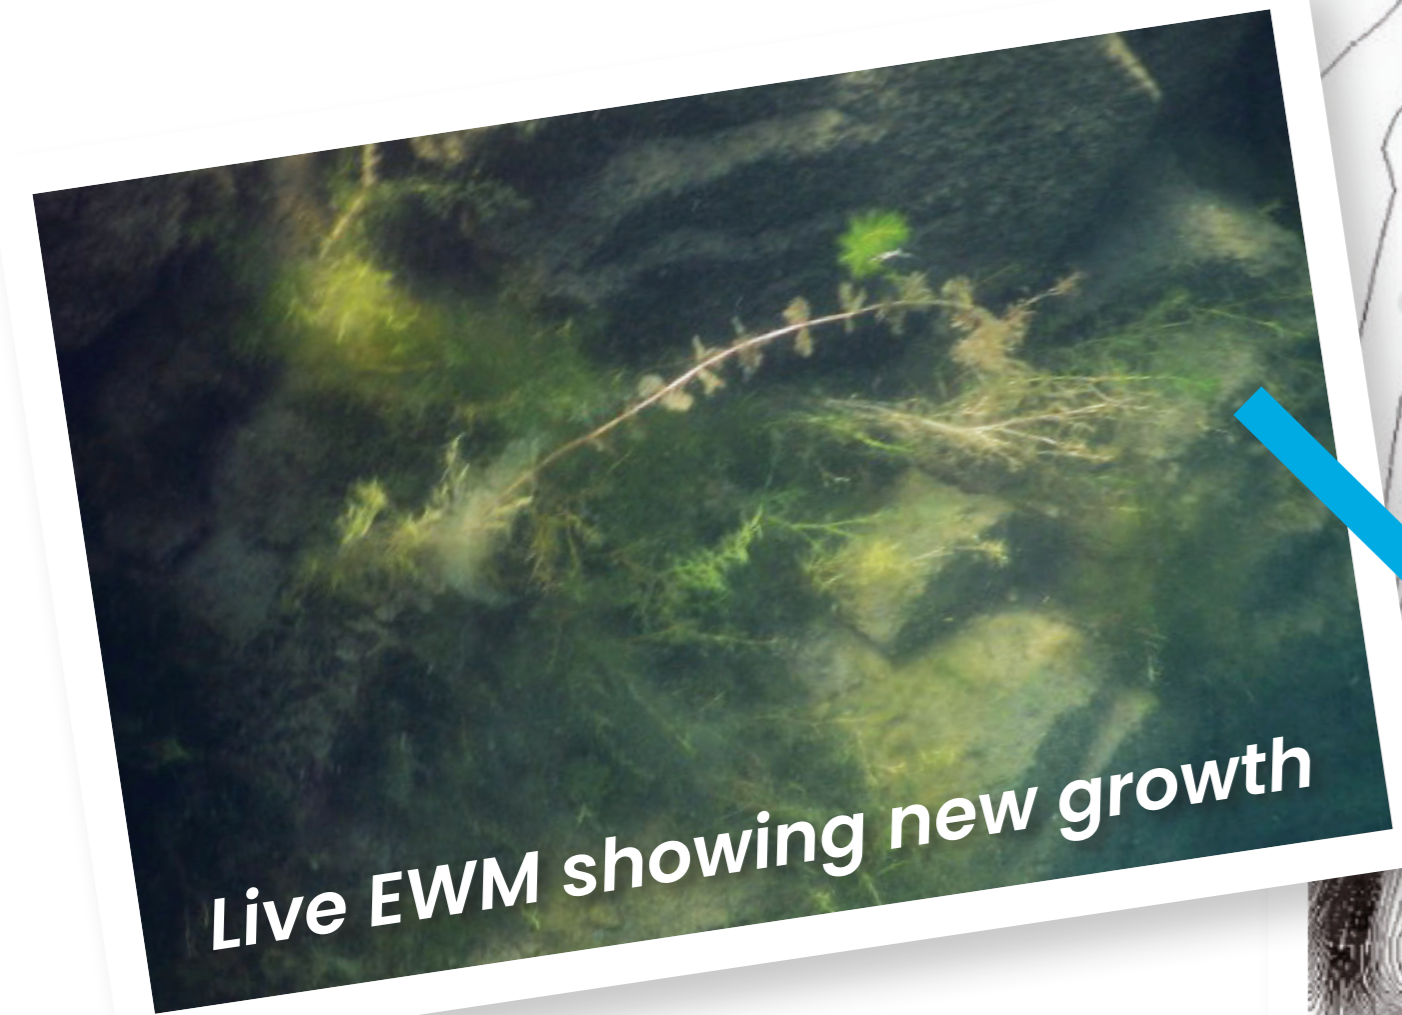
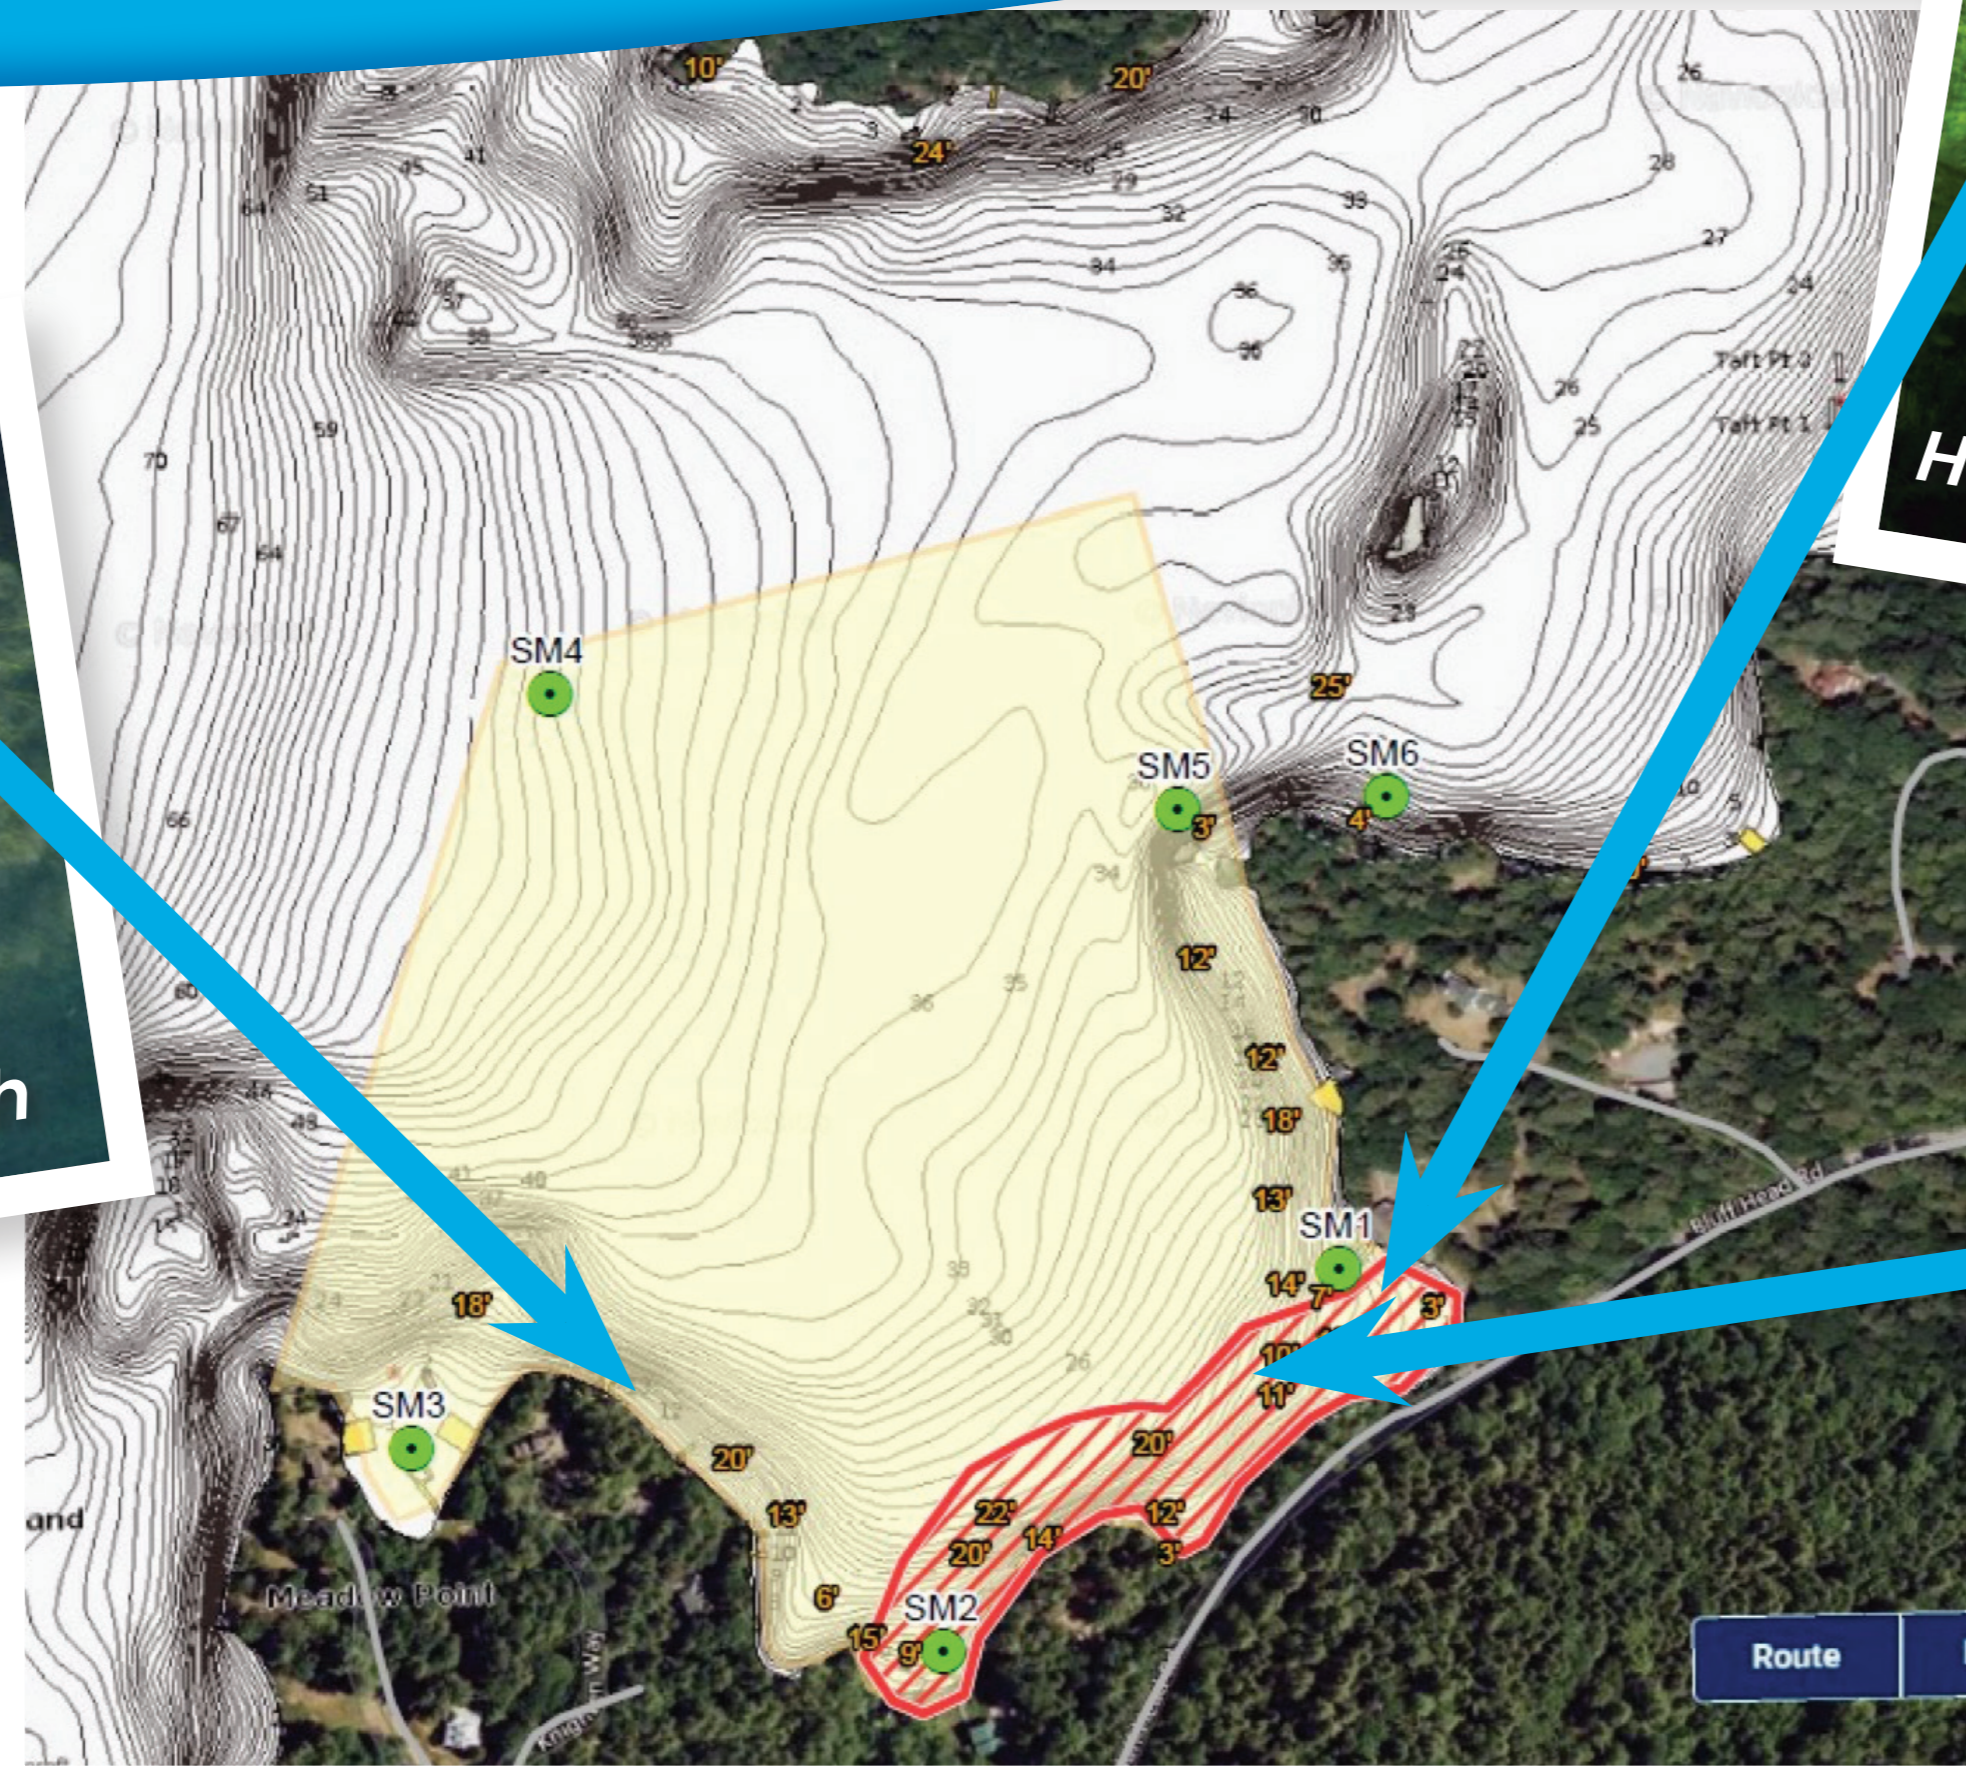
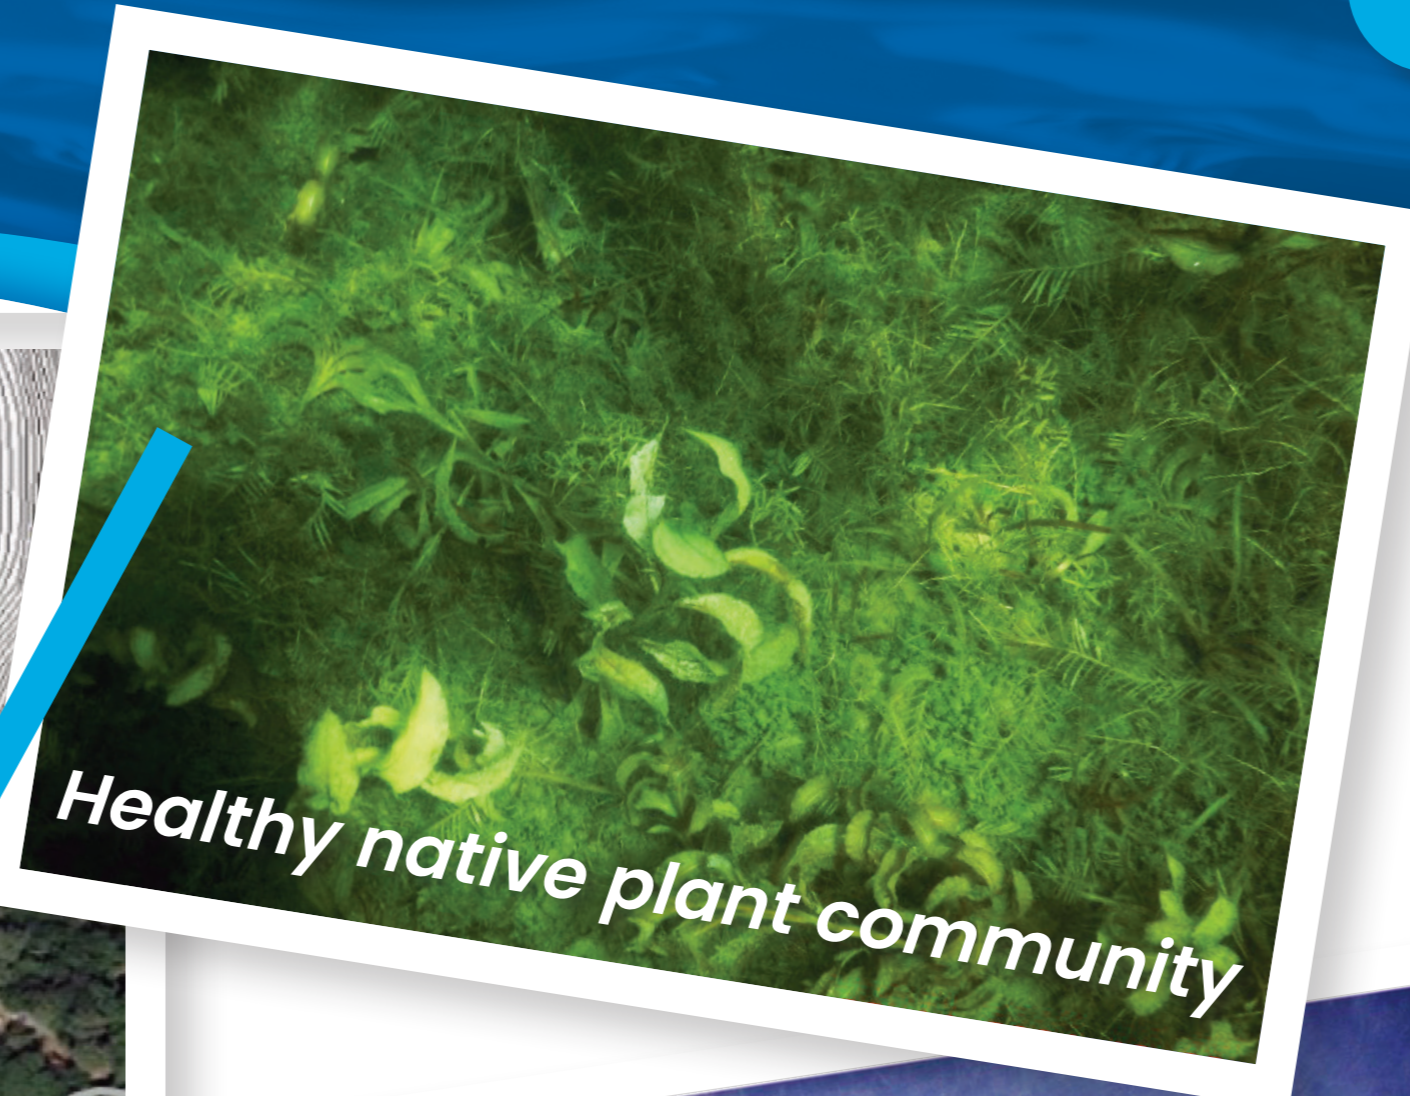
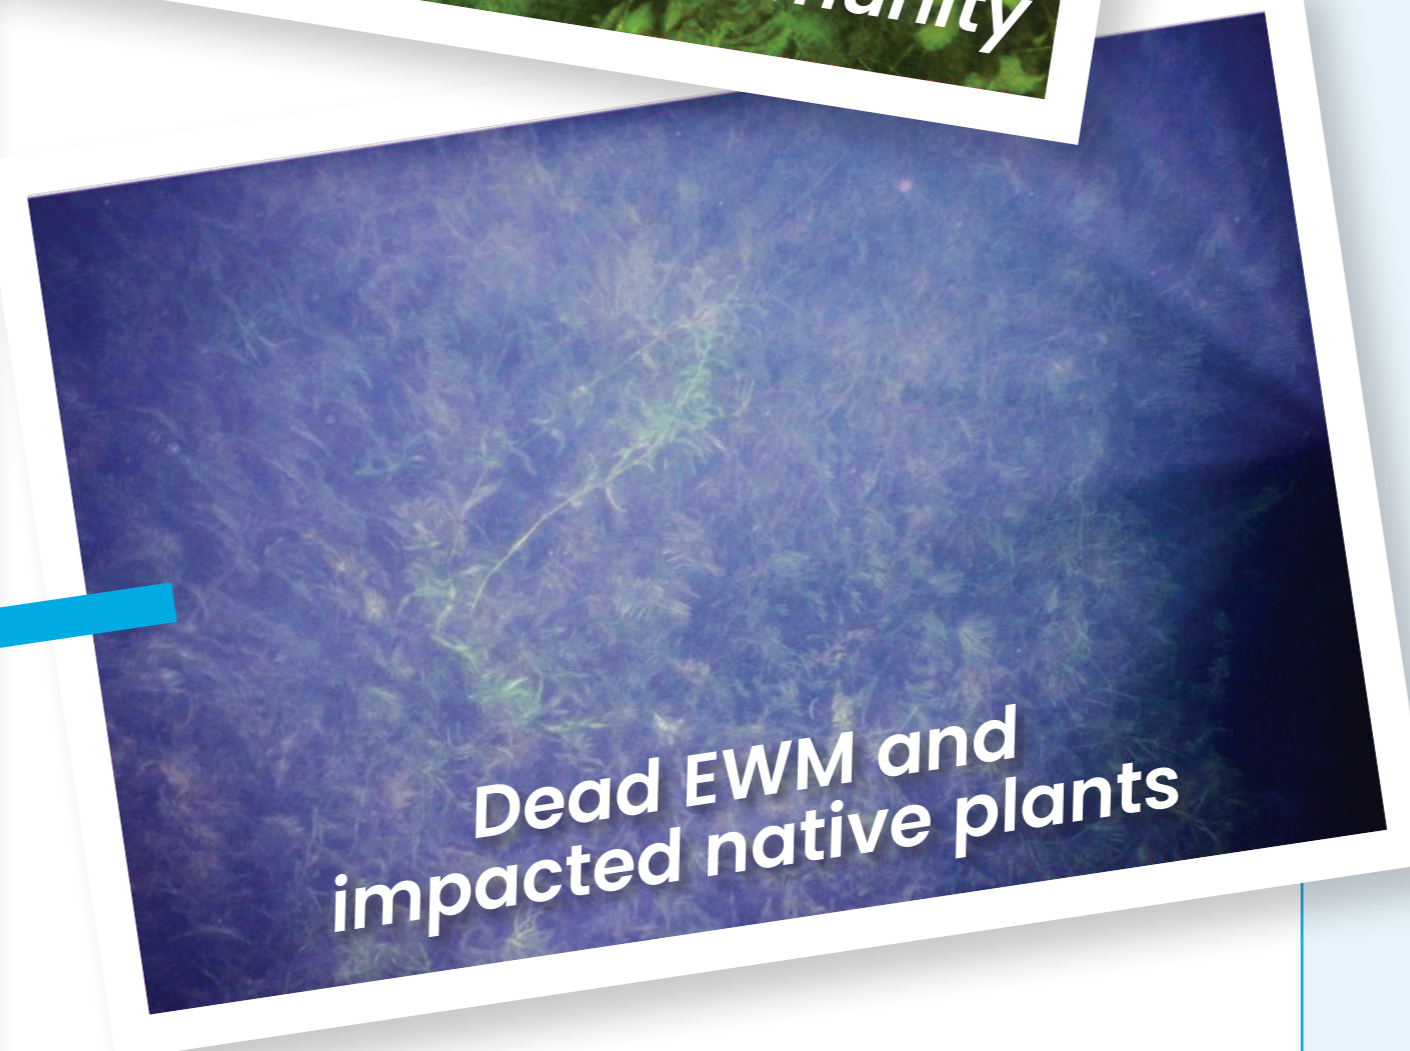
Uneven Impacts on EWM

In the treatment zone of Jelliffe-Knight Bay, we found potential signs of impact on native plants among the dead Eurasian watermilfoil with clouds of algae above it, as well as areas of healthy native plants. In the dilution zone, EWM with new growth was observed.

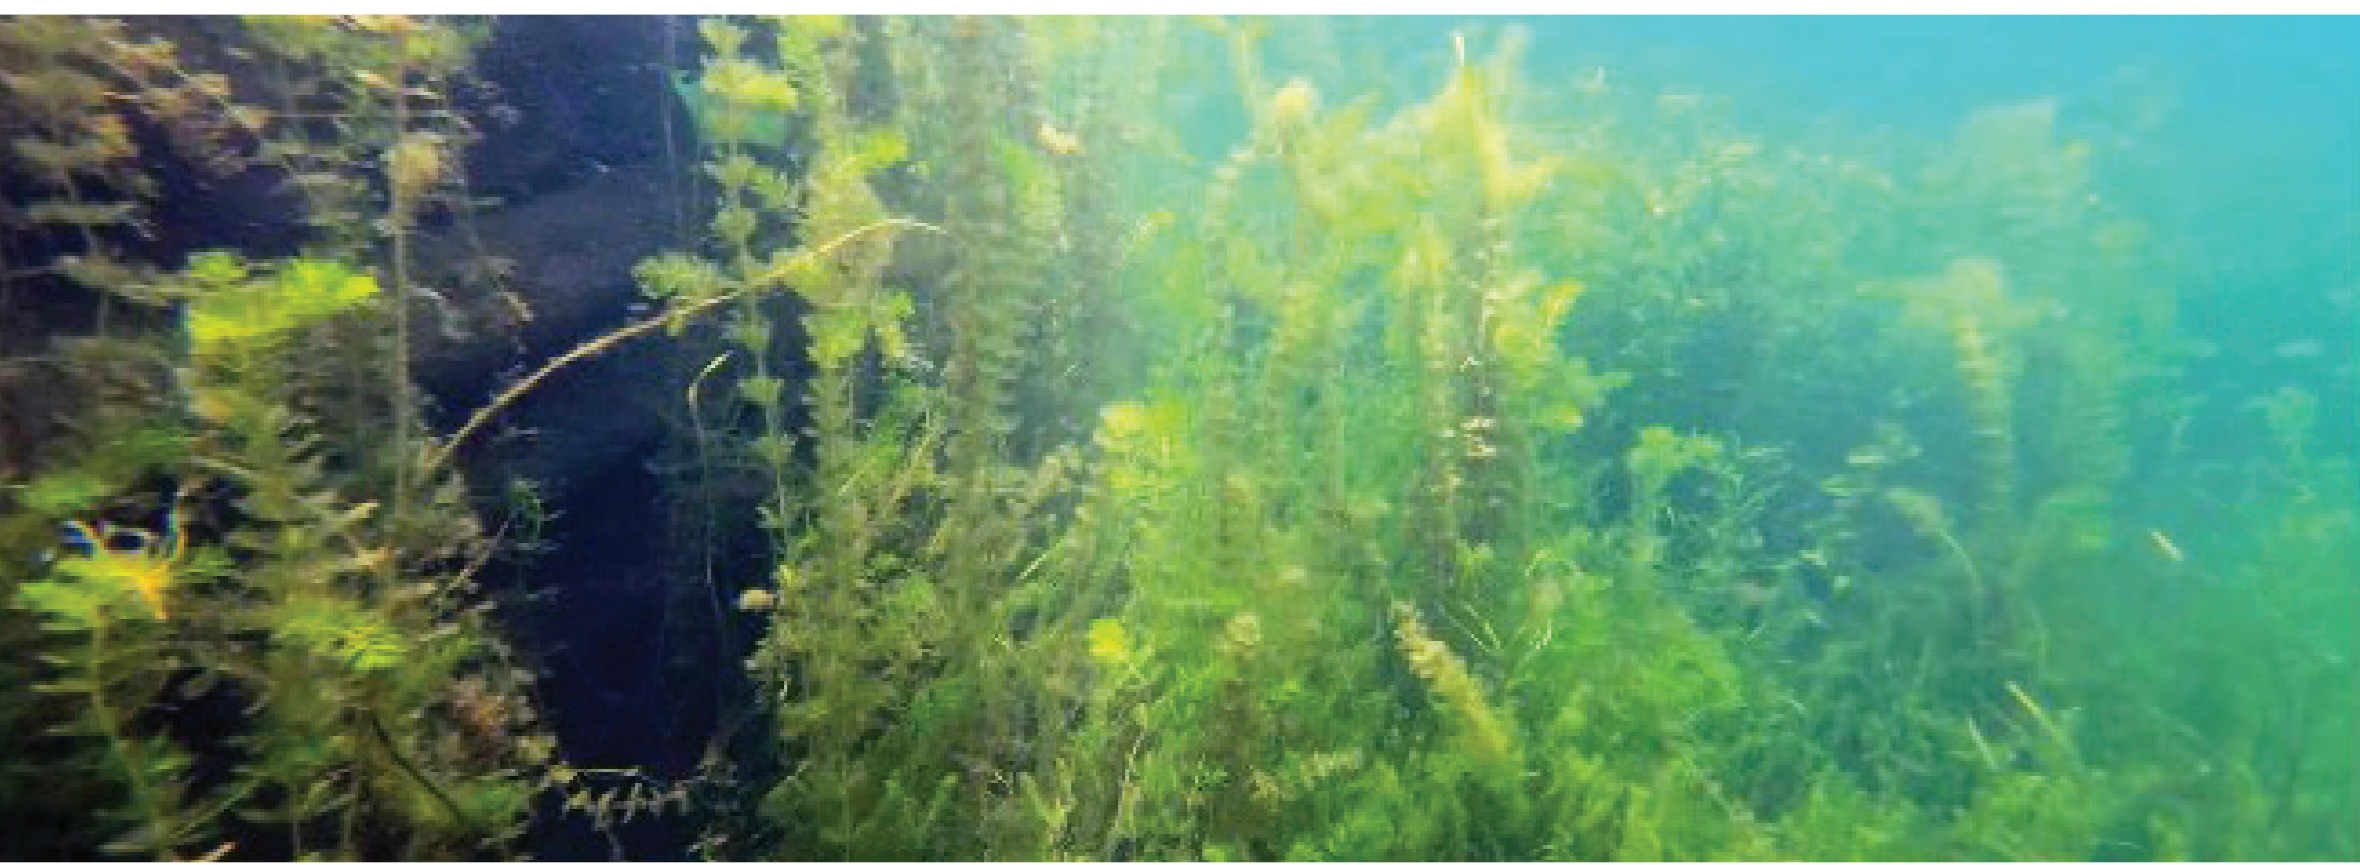
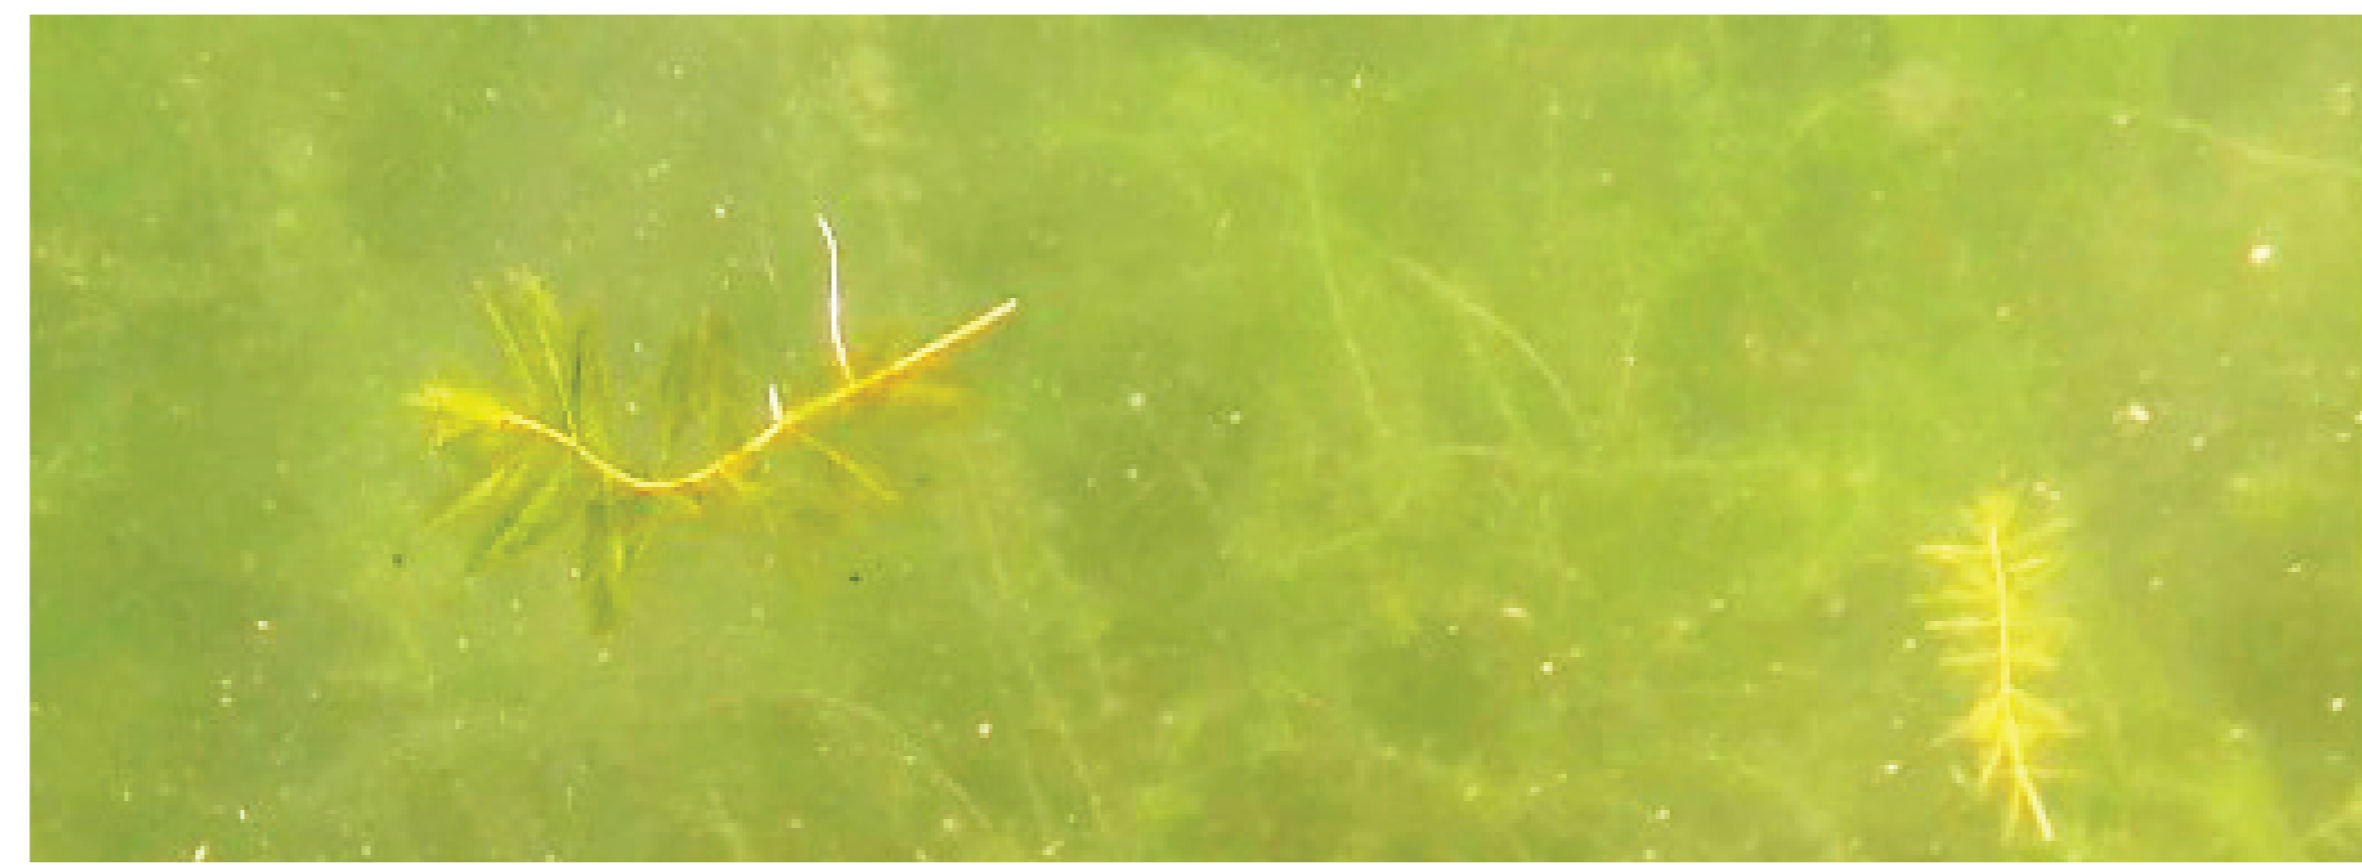
A Closer Look at Blairs Bay

In the top photos of the northern treatment zone, we see healthy EWM plants as well as auto-segmenting, which is when tips of EWM release from the plant with adventitious roots that enable it to propagate.
