Effects of ProcellaCOR in Lake George

Initial results from the monitoring of Blairs Bay and Jelliffe-Knight Bay by The Jefferson Project and the Lake George Association (LGA)

September 3, 2024

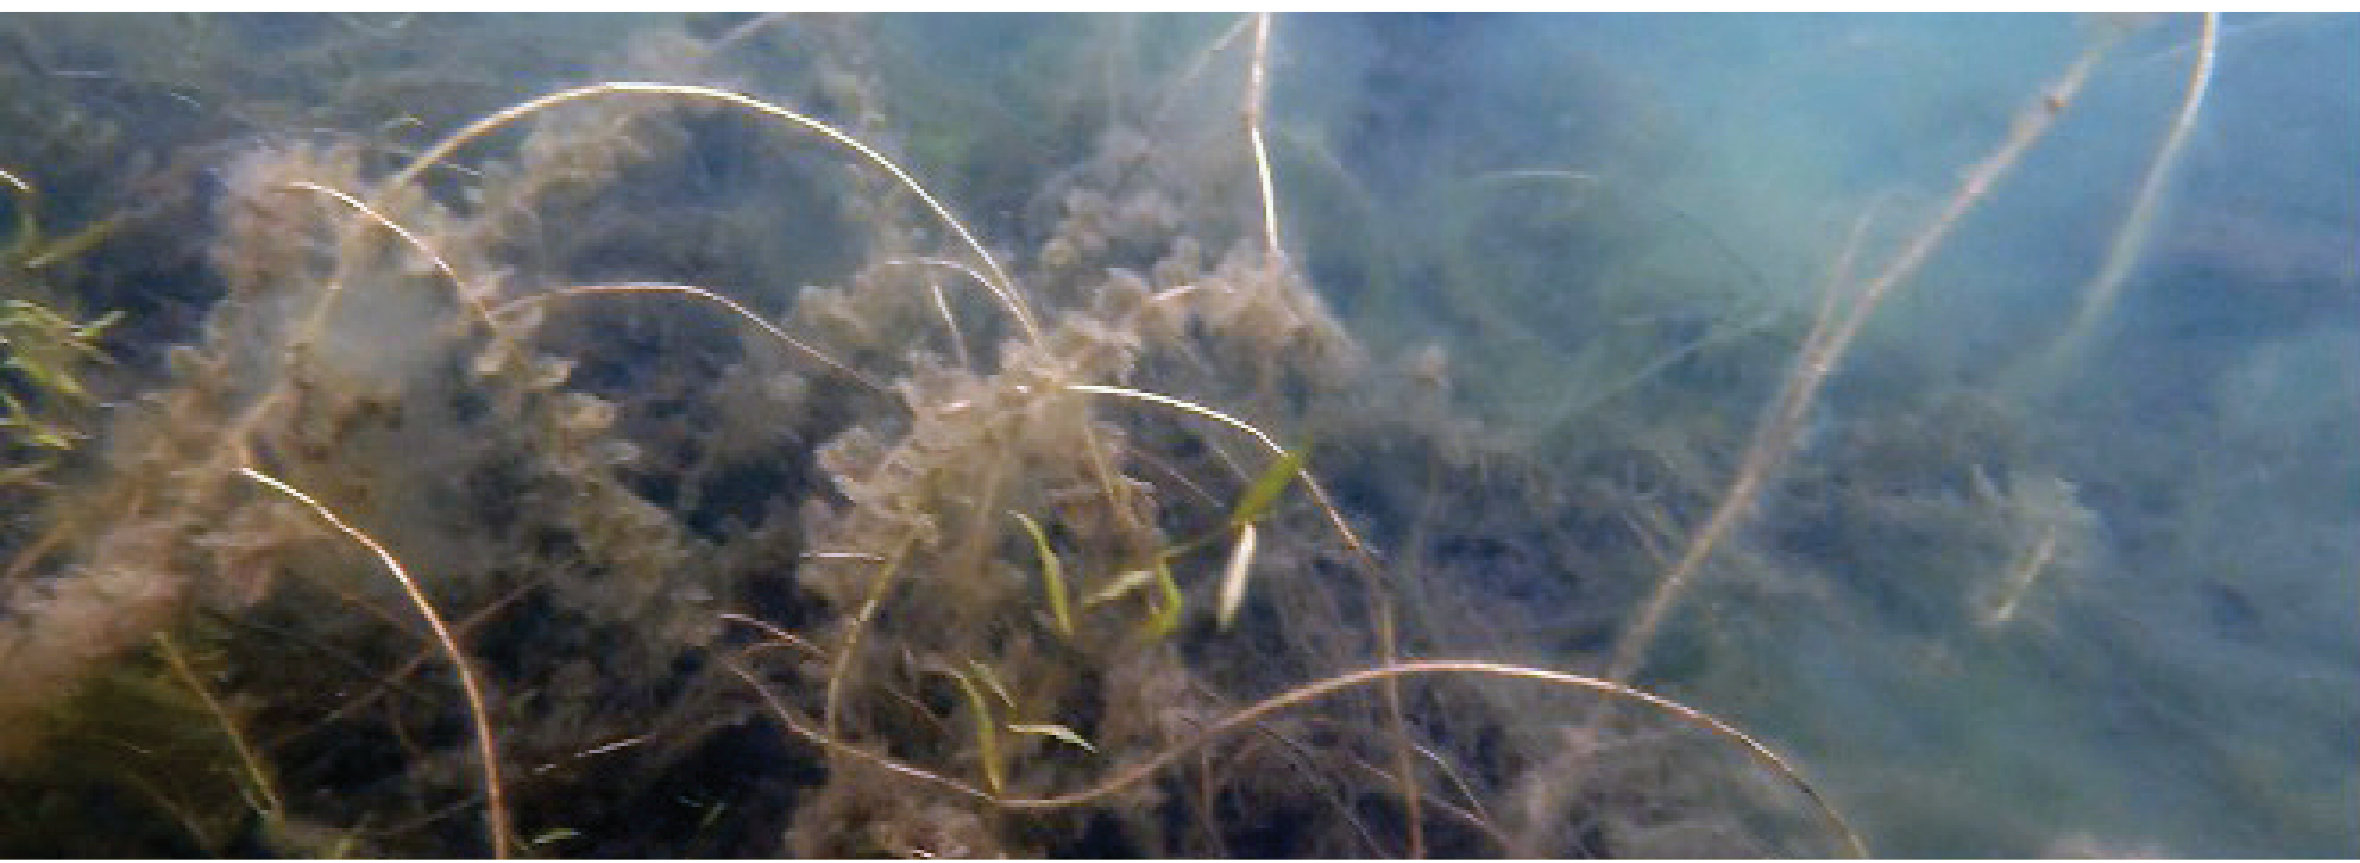
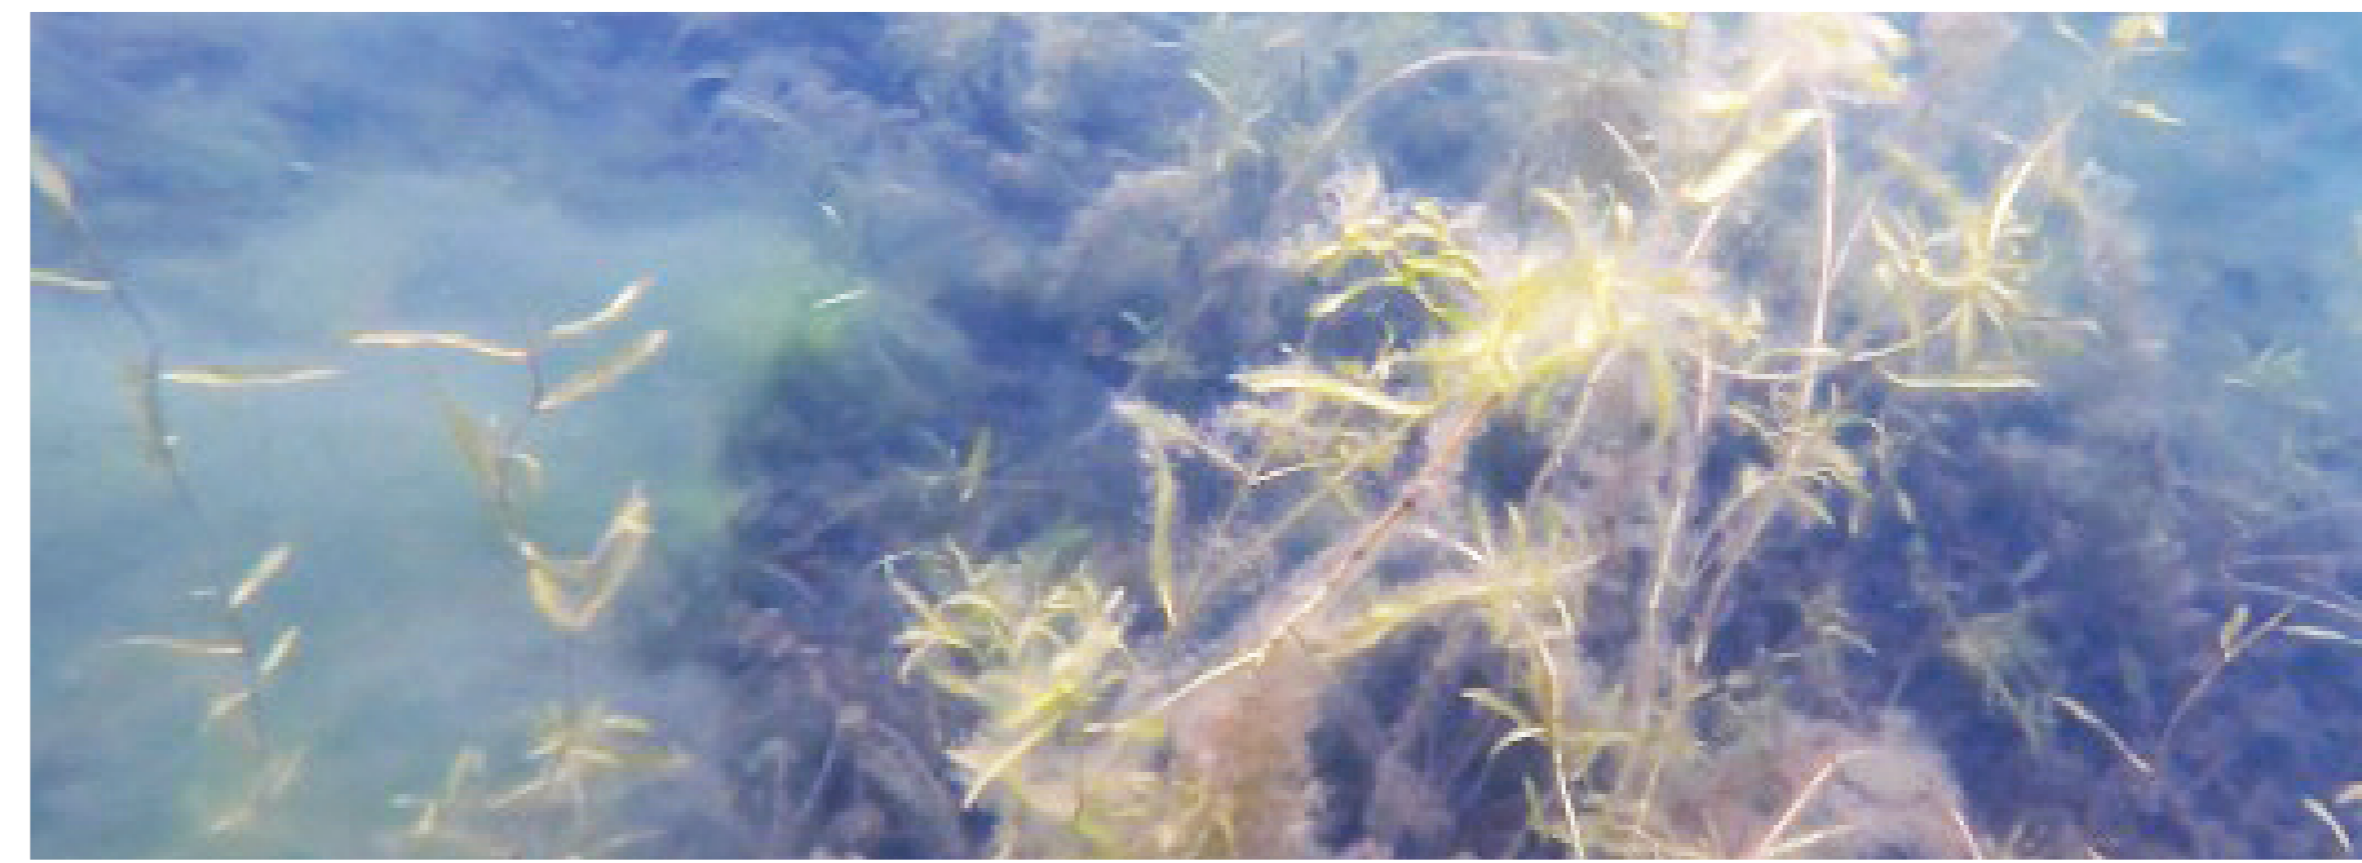
The bottom photos, also in the treatment zone, show clouds of filamentous algae over the dead EWM. It is likely the decaying plants released nutrients and organic matter on which algae feed, causing them to multiply and create blooms.

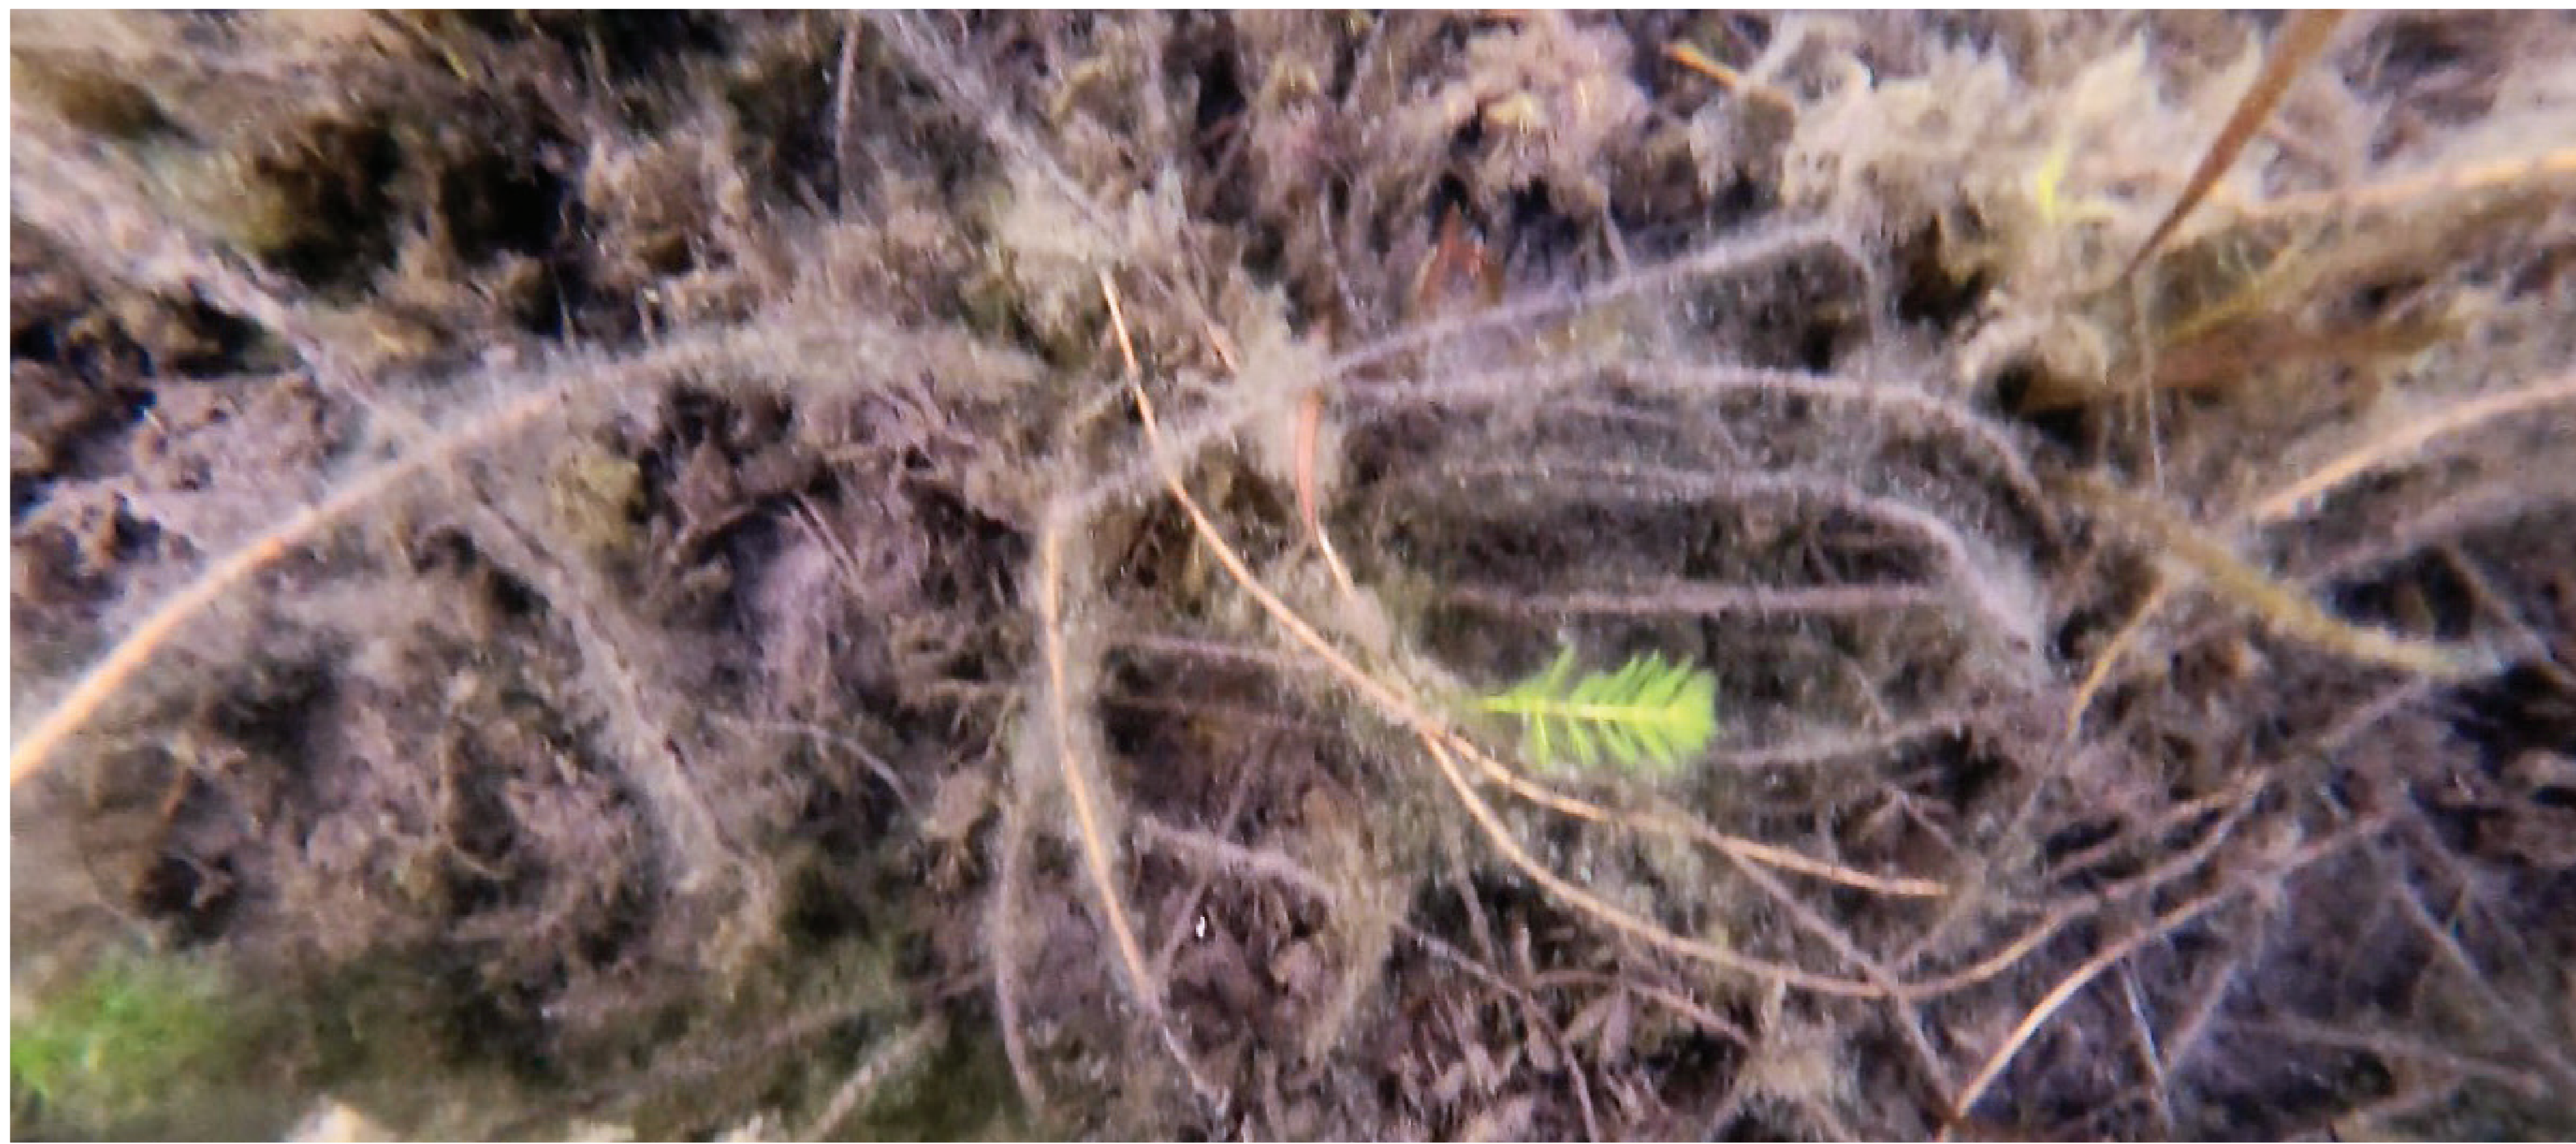
Growth Among Decaying EWM

In Blairs Bay, we found new growth from a decaying Eurasian watermilfoil stem, as shown here on August 2 in the treatment zone.

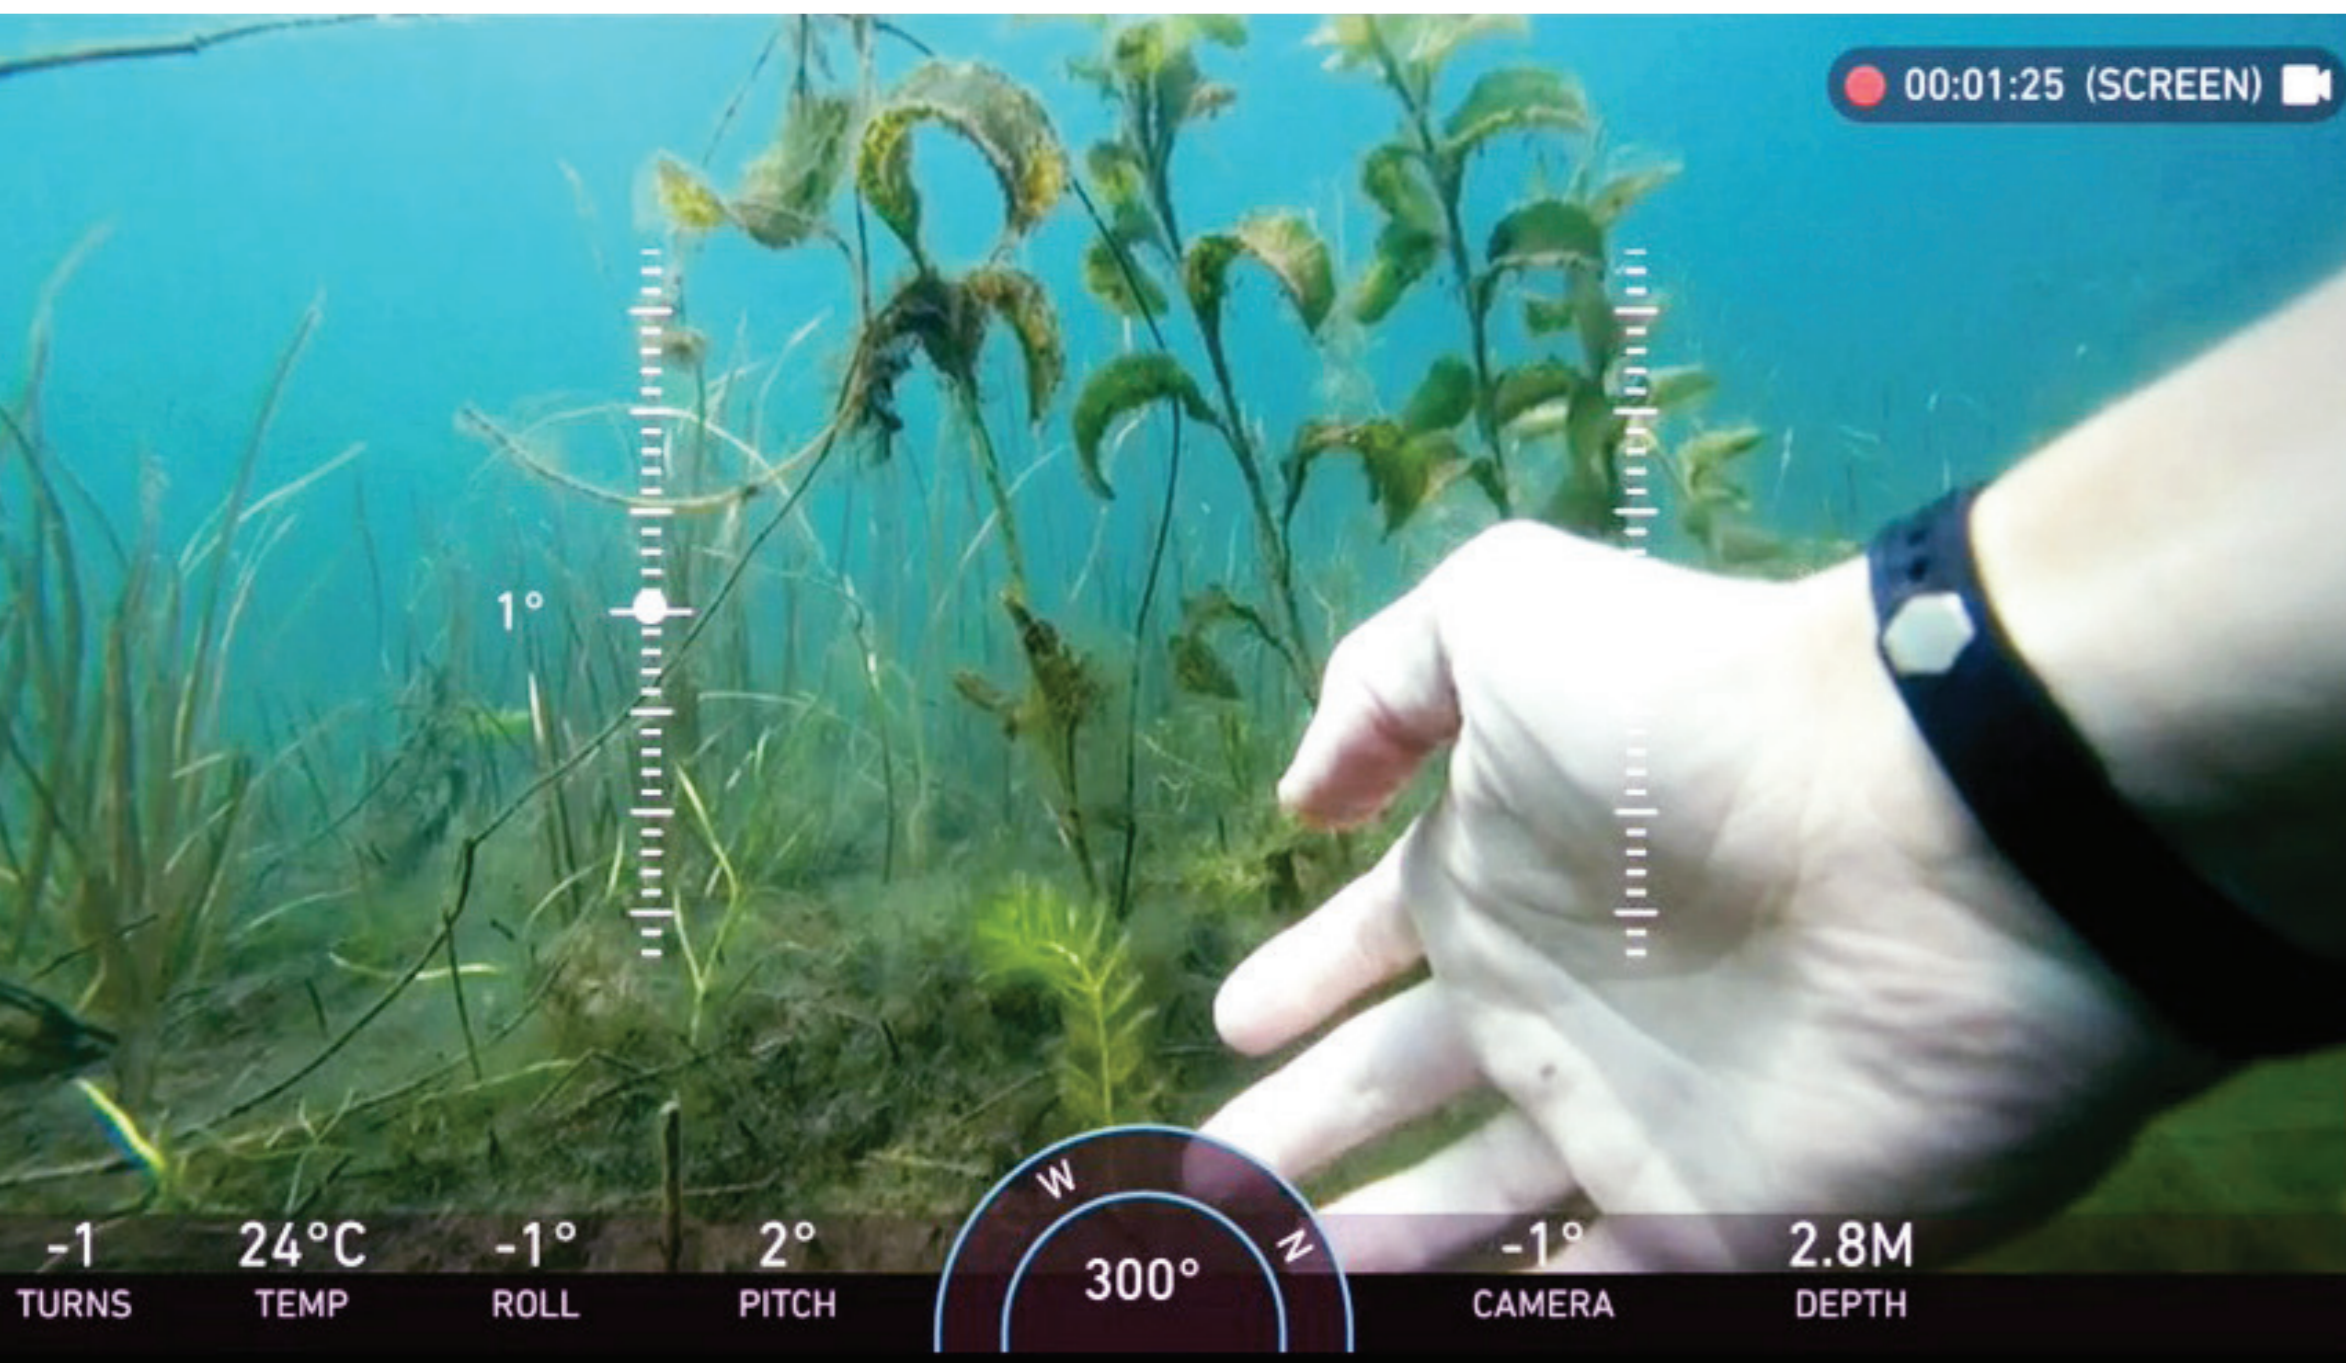
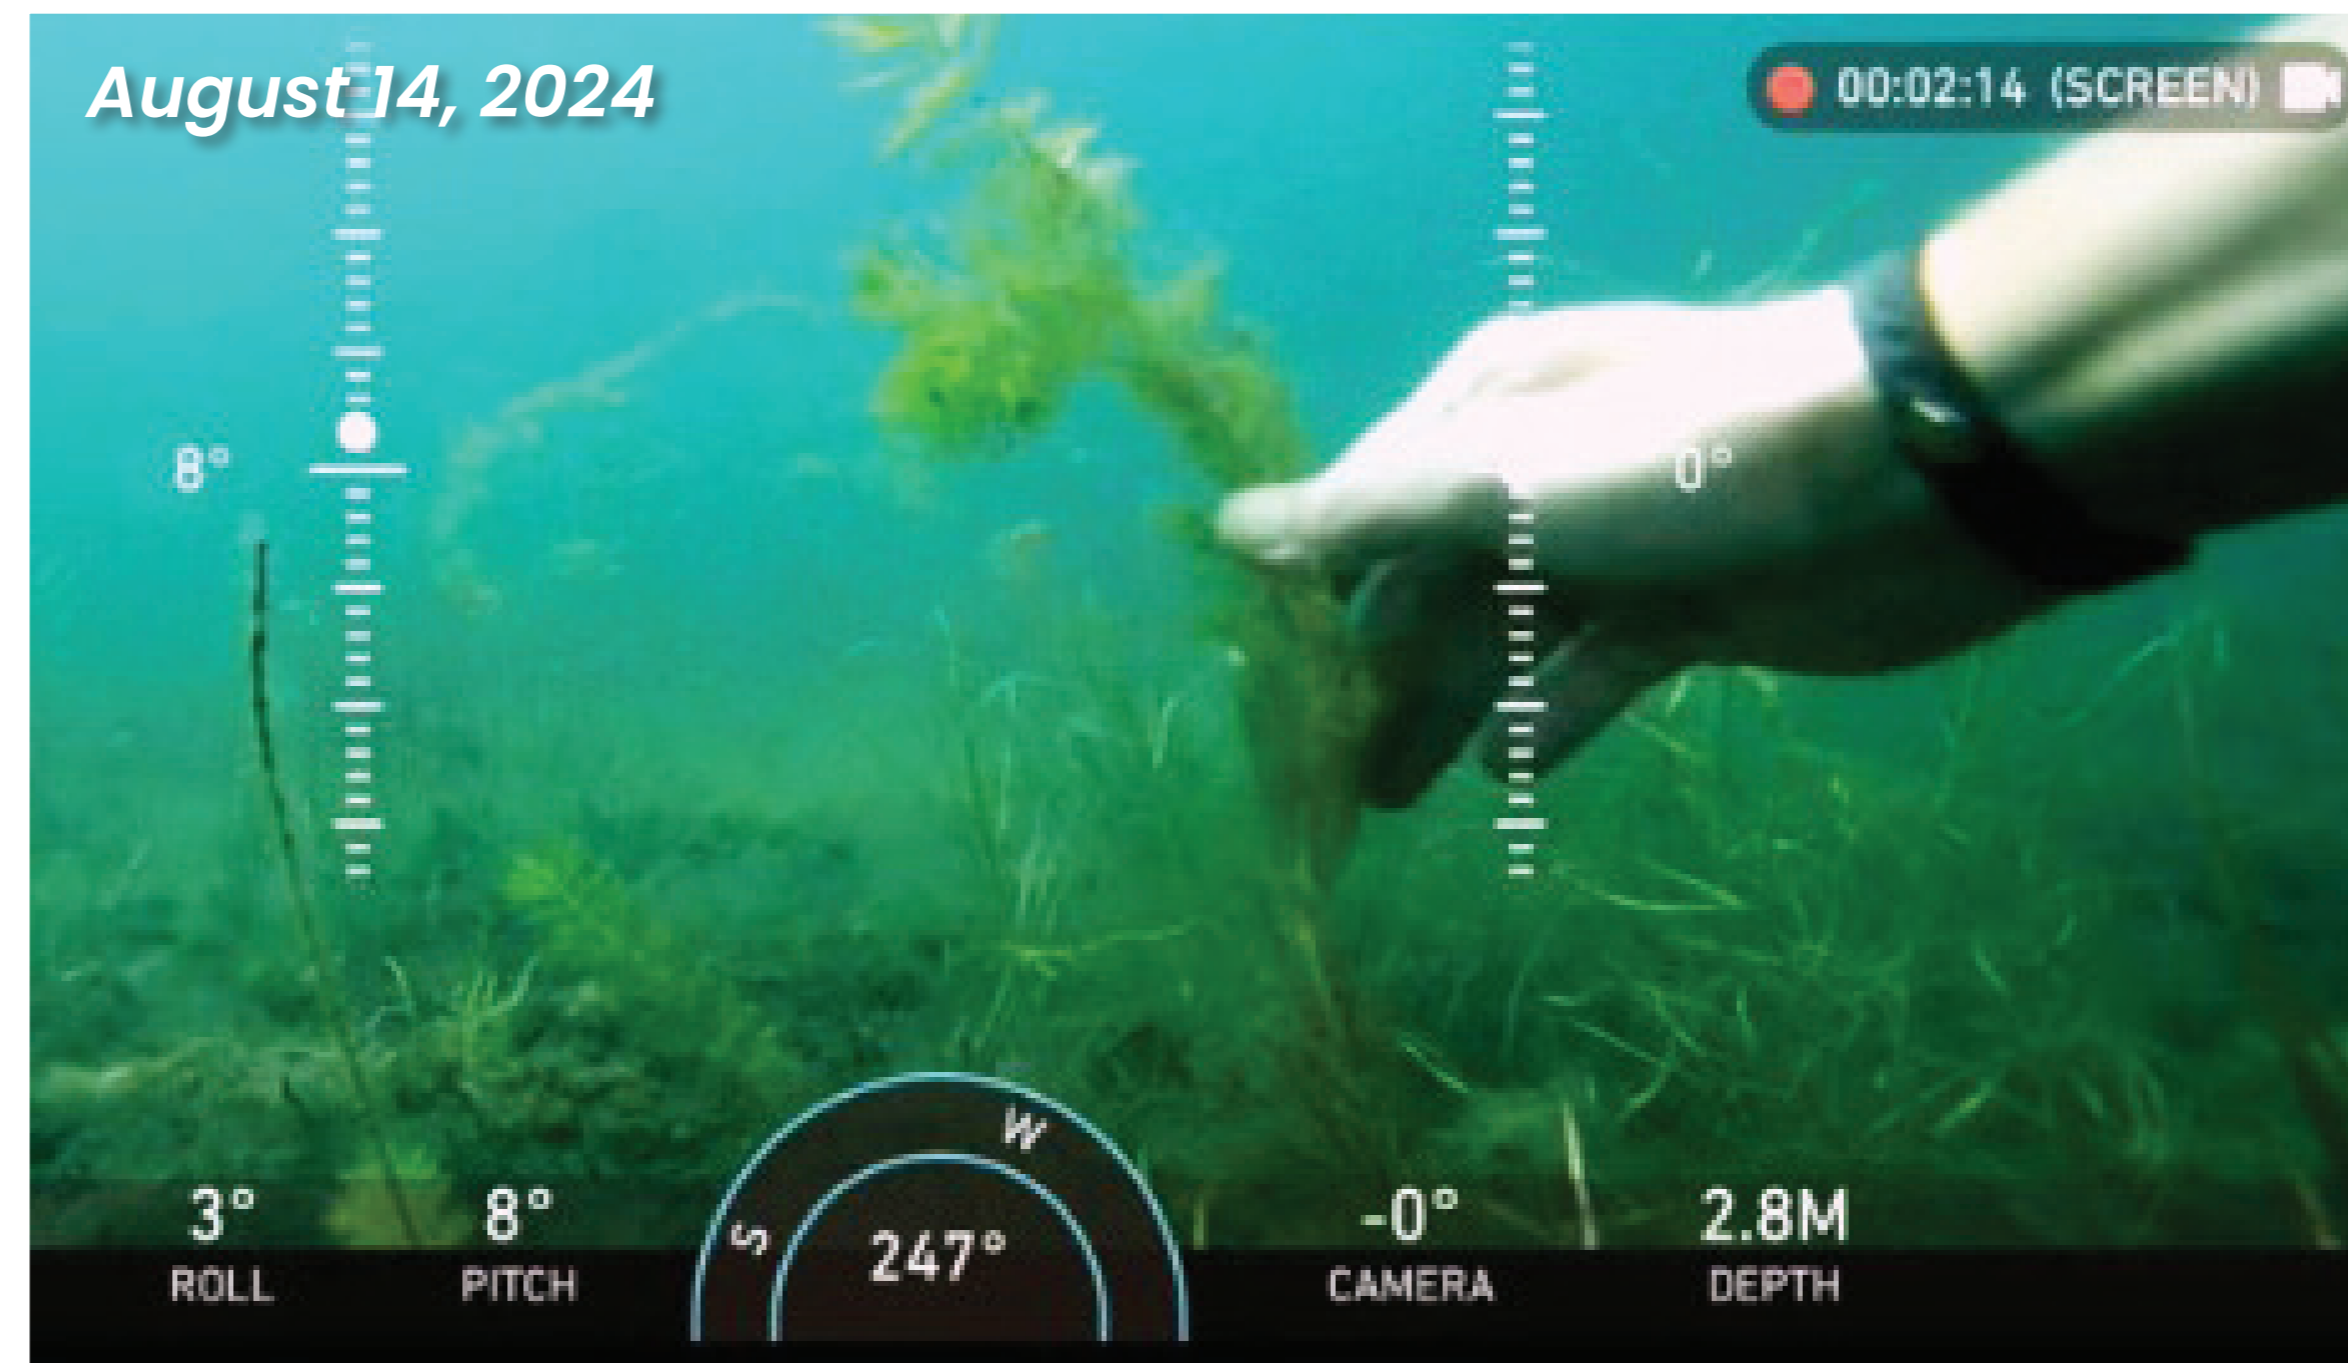
New EWM Growth Prompts Questions

The emergence of new EWM in several areas in the Blairs Bay treatment zone where much of the invasive was killed begs the questions: Did this EWM survive the treatment? Is this new growth? Is it both?

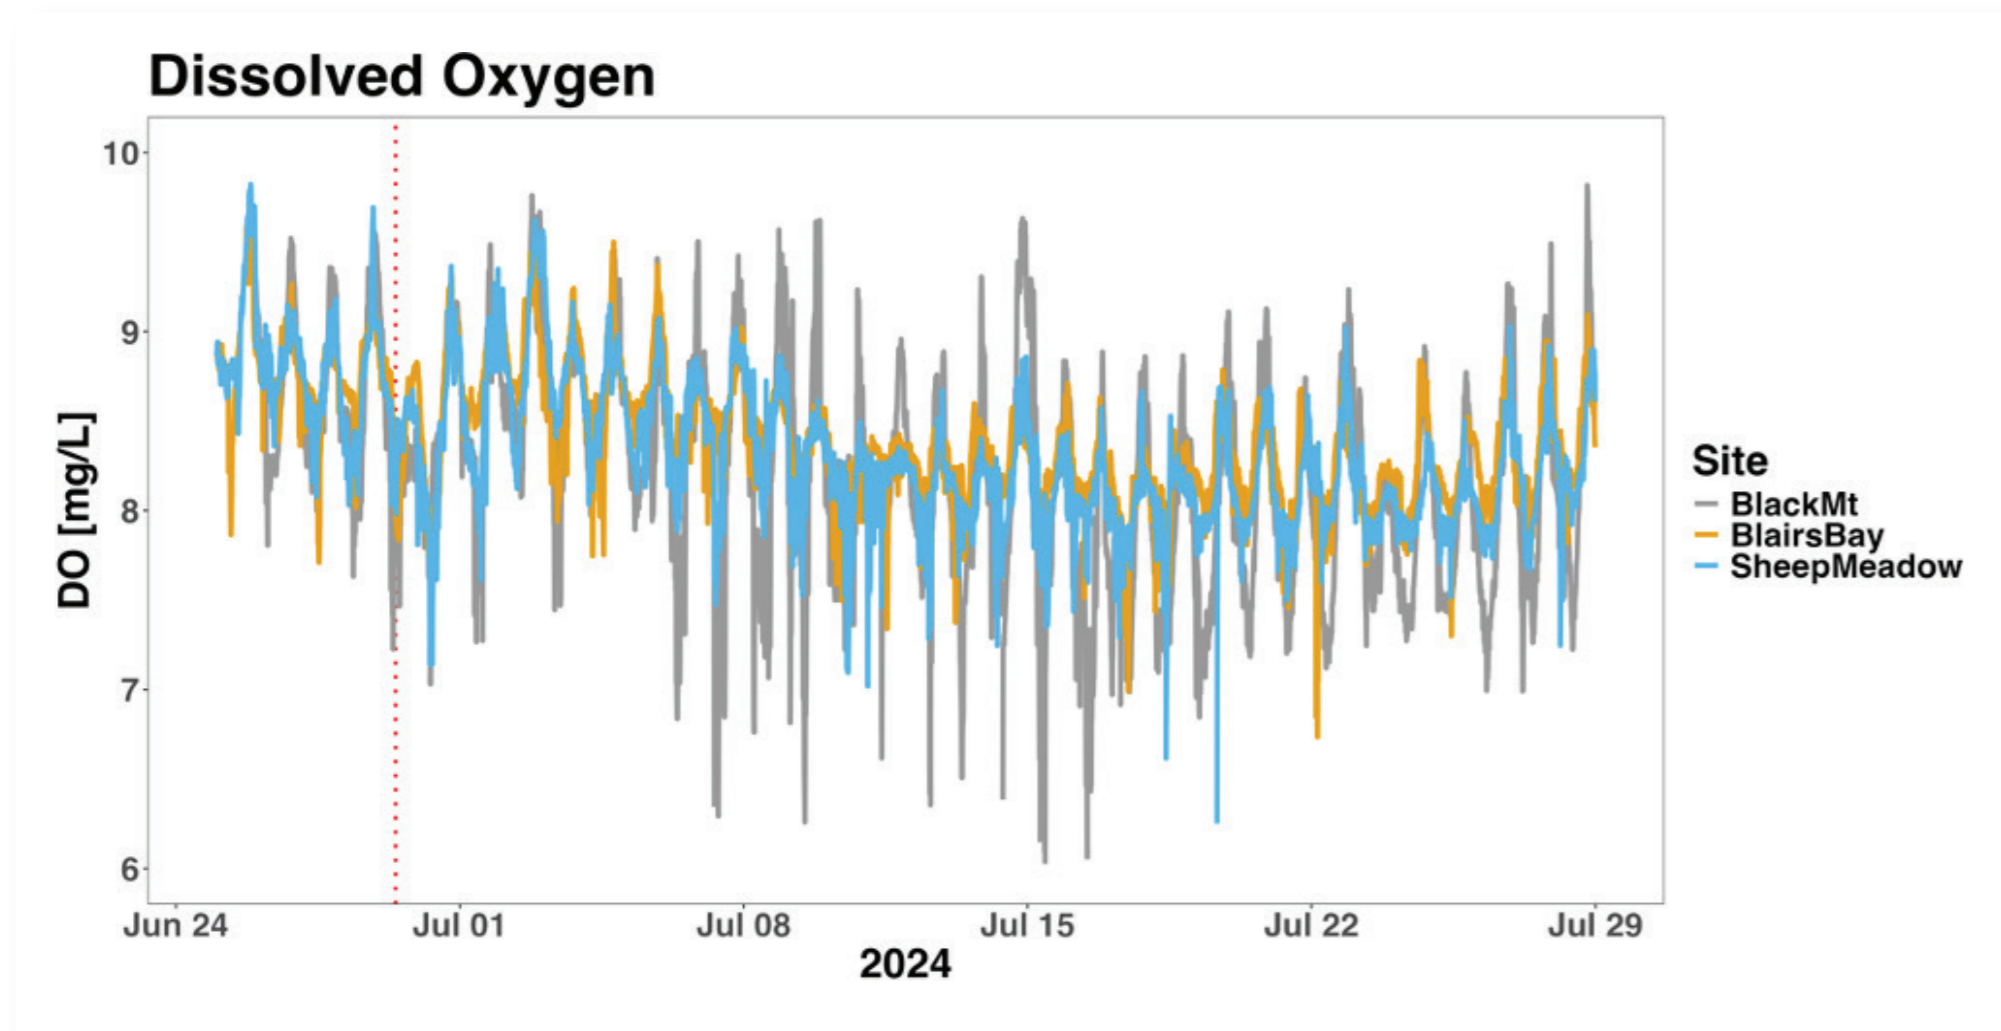
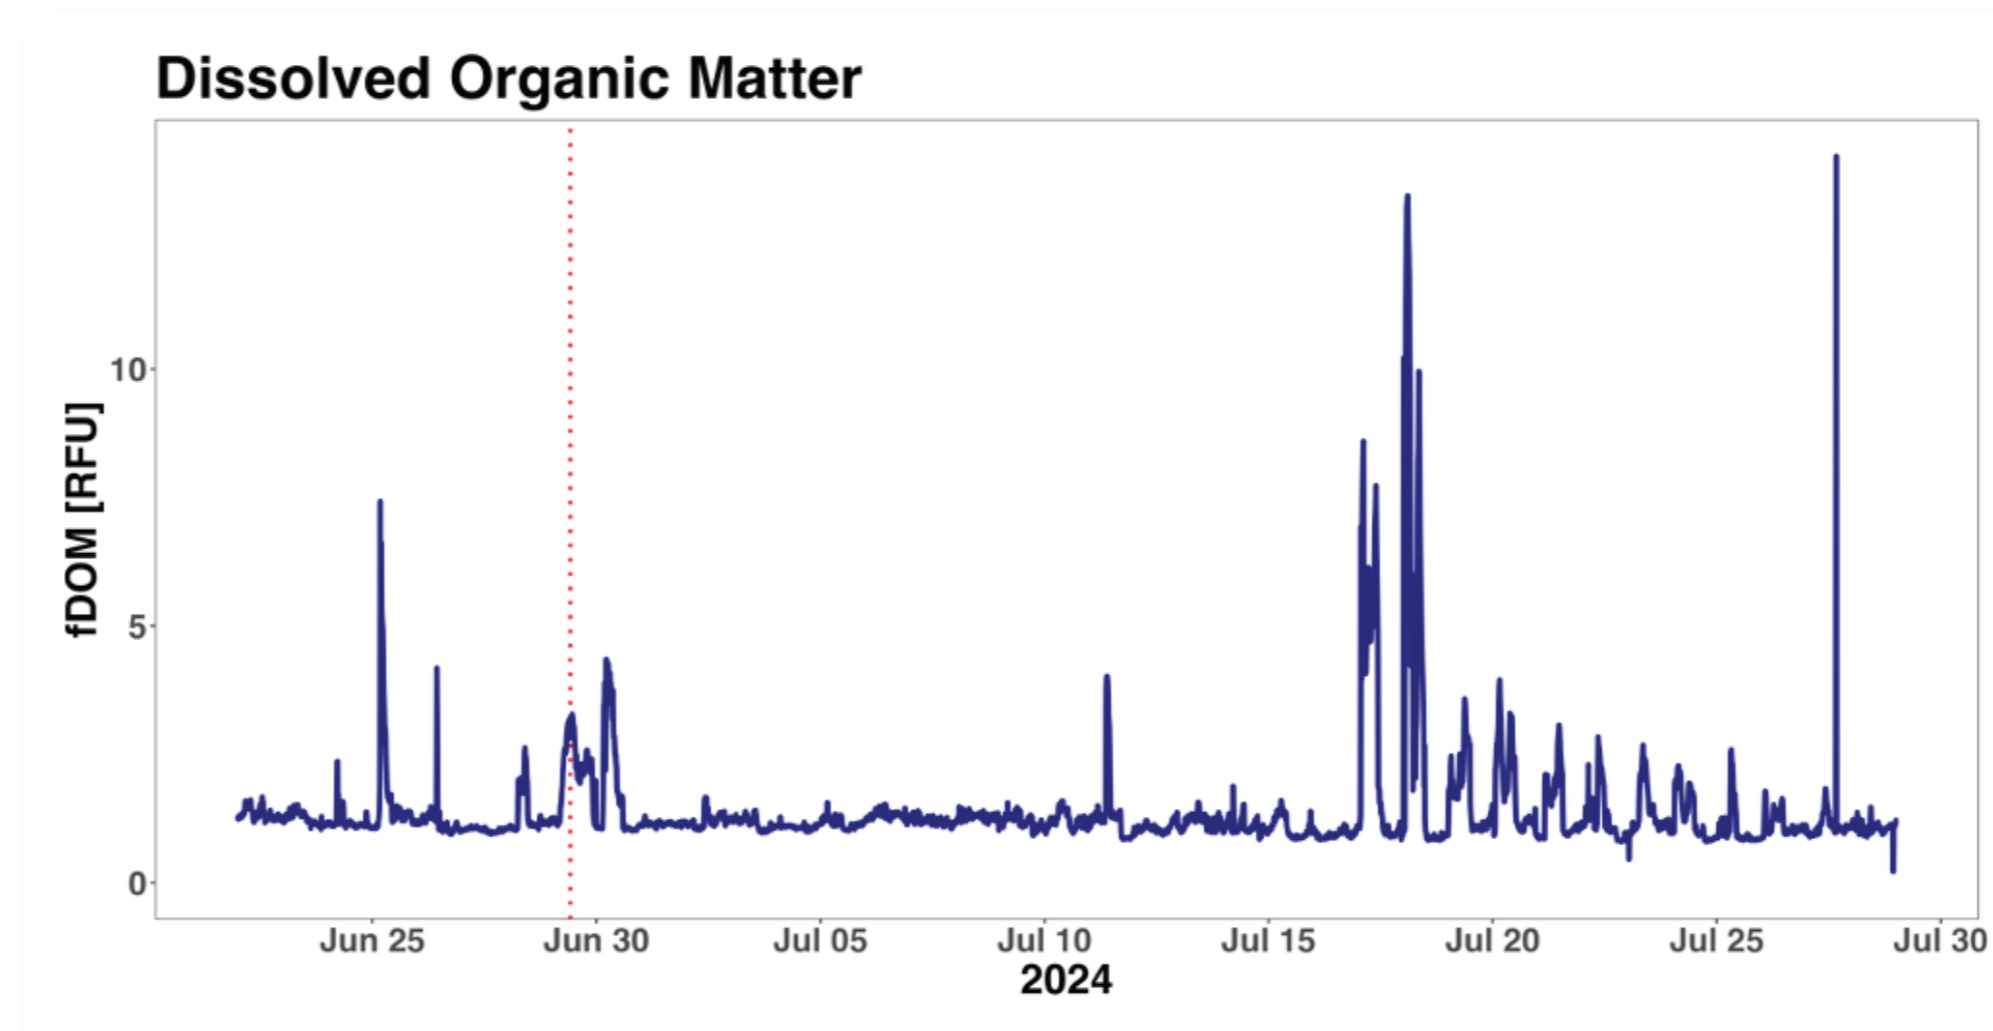
Decaying Plants Impact Ecosystem

Plant productivity (photosynthesis) was lessened, as indicated by the lower amounts of dissolved oxygen in the treatment zones of Blairs and Jelliffe-Knight Bays compared with a control bay in Black Mountain Point. Microbial breakdown of the plants also could have lowered dissolved oxygen levels.

The sudden increase in decomposing plants in the treatment zone put more dissolved organic matter as well as nutrients into the water, likely causing an increase in algae growth over the decaying plants.
